Neath Abbey Ironworks

Summary of Structural Investigation

The Friends of Neath Abbey Iron Company

Project Number: 9446

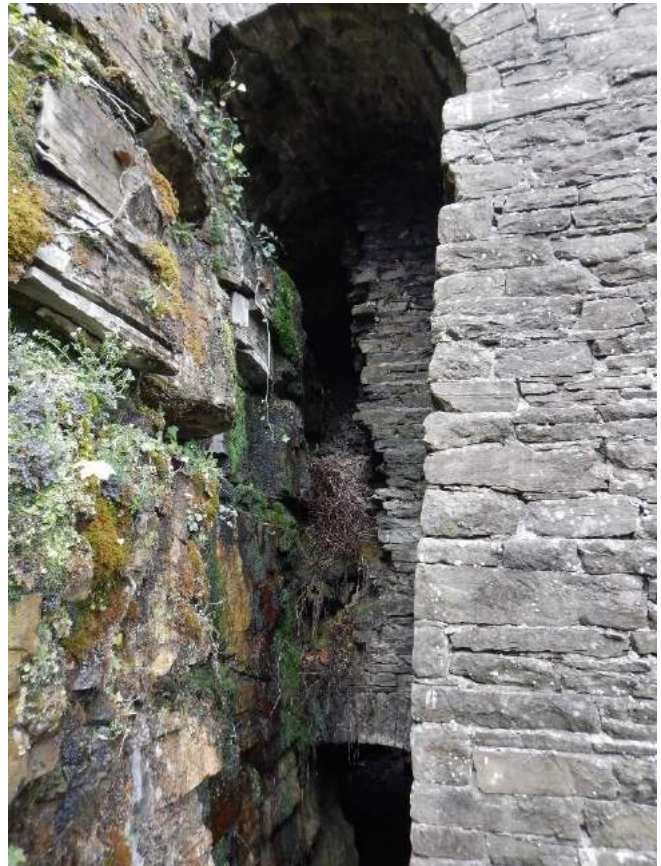
4.1.2.2 The infill wall between the two arches has failed historically leaving a rough masonry edge approximately halfway between the west elevation and cliff. Behind the open section a rough rubble slope is visible running up to the soffit of the upper arch. The slope has accumulated debris, such as dead vegetation, which is held at high level. Access to inspect this area was limited due to the narrow entrance.

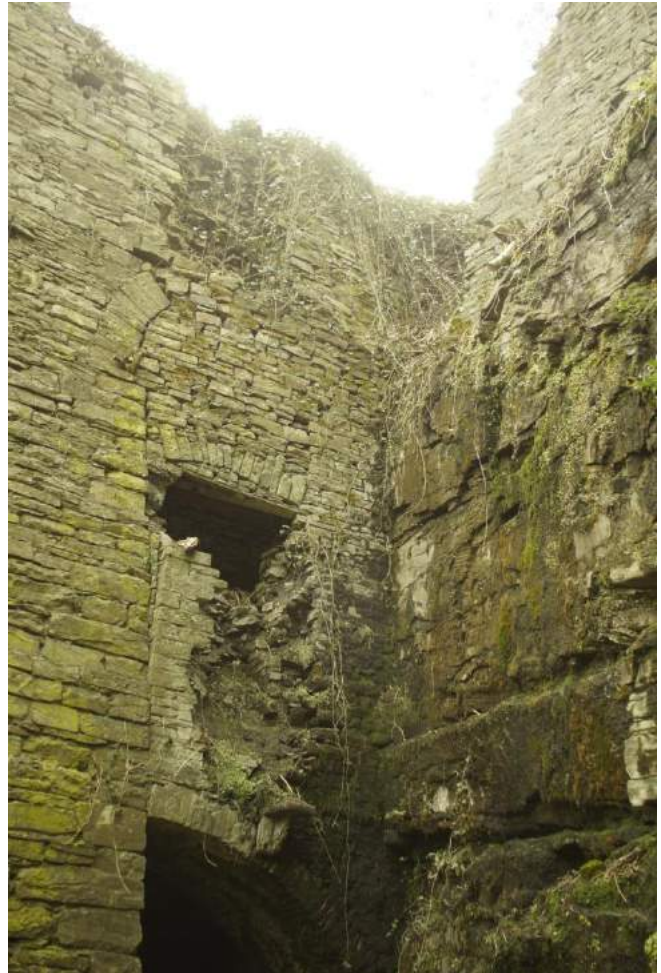
4.1.3.1 The arches between the west elevation and the cliff are similar on the north elevation to the south. However, here there is an additional lower arch flush with the west elevation. This arch is distinct as it is half an arch, the soffit changes to a full arch approx. 1m back from the elevation matching the south side. The infill between the two arches is also flush with the north elevation but a second infill is visible behind approximately on the line of the full lower arch. There are a number of defects in this area showing a progression of failures and repairs.

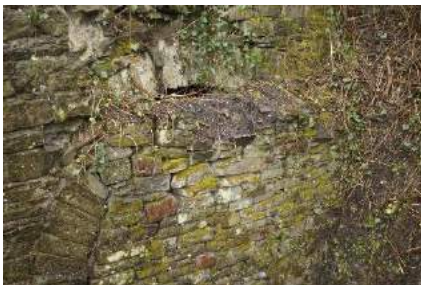
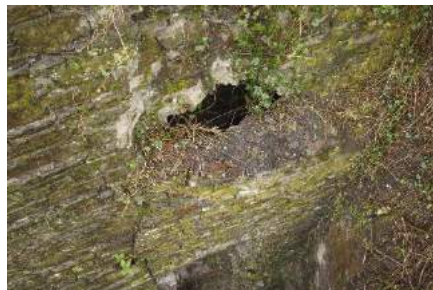
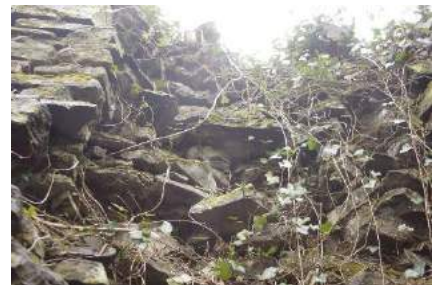
4.1.3.2 The upper arch between the west elevation and the cliff has failed leaving a section of the facing stonework above unsupported which has also failed. From the remaining facing stone, the arch must have raked back from its springing. The infill wall runs through the line of the failed arch but vertically, so it is offset out from the original facing stone above. This infill is poorly constructed with little or no mortar and can be manually deflected.

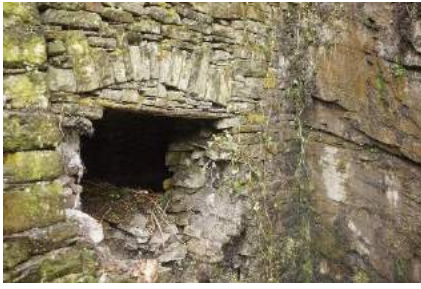
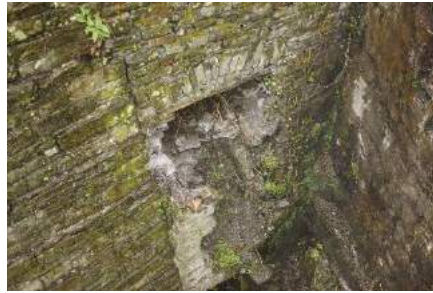
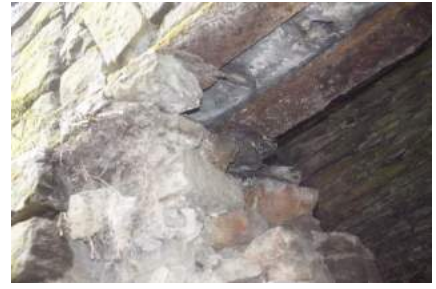
4.1.3.3 Below this infill panel is a shallow stone arch and steel lintel over an opening. The lintel is in very poor condition and visibly deflected. Both bearings of the lintel are poor with very little contact to distressed and loose stonework.

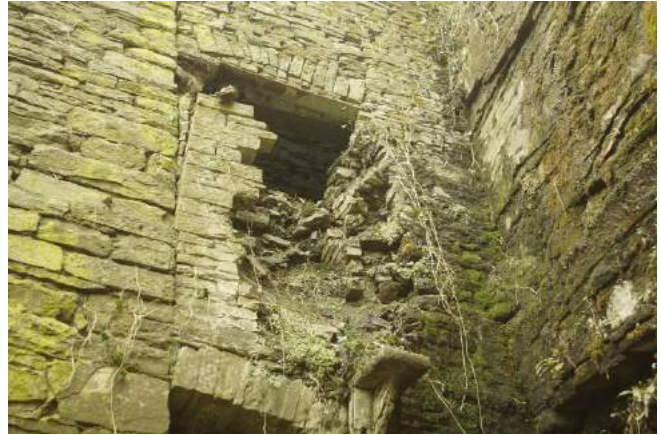
- 4.1.3.4 Below the lintel there is a rough opening in the stonework with much loose and displaced stonework down to the lower arch. The masonry adjacent to the furnace is not tied into it, there is no evidence of the original opening and there is a rough slope of exposed corework or rubble.

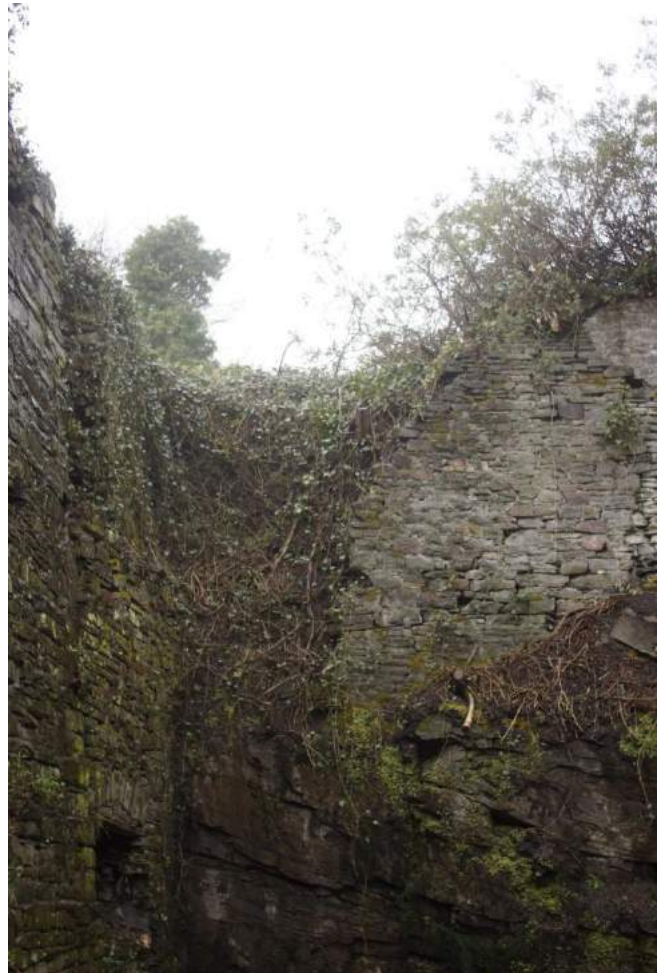
- 4.1.3.5 At the top of the cliff is a stone retaining wall in line with the cliff. Adjacent to the furnace this has failed over a 2m length. The material from this collapse is visible at the base of the cliff. This has left a steep earth bank and a rough end of the stone retaining wall with some loose stones. The client informed us additional material had fallen from this area during a local minor earthquake in 2018.

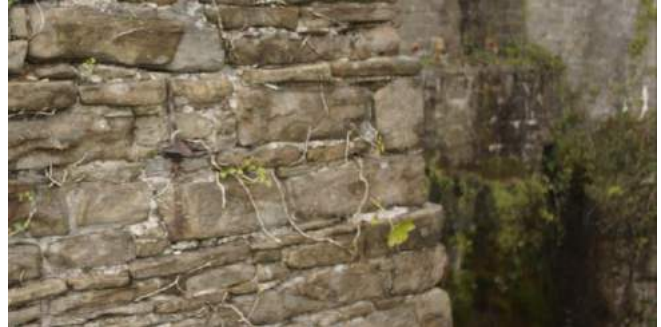
4.1.4.1 All faces of both furnaces (except the west faces) have evidence of significant vertical cracks near the centre of the elevations. In some places these are open up to 150mm and were measured as up to 800mm deep. These cracks are shown on undated historic photographs of the furnaces and there is evidence of partial repairs and rebuilding from the 1995 works.

4.1.4.2 FNAICO stated Jennifer Protheroe-Jones, curator National Museum Wales, told them the small brackets on the outside of both furnaces near the tops held wrought iron straps to reinforce and hold together the furnaces. This strengthens the argument for the cracks being caused during operation of the furnaces.

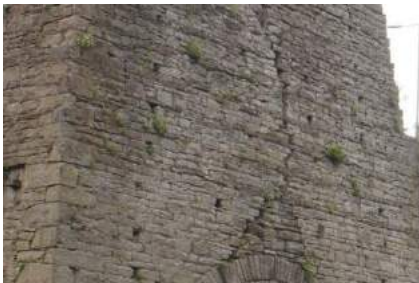
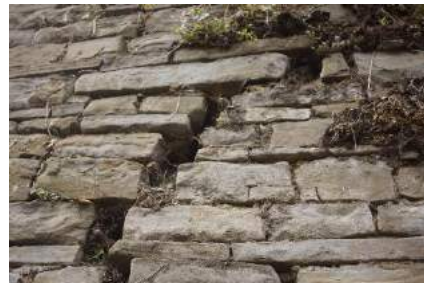
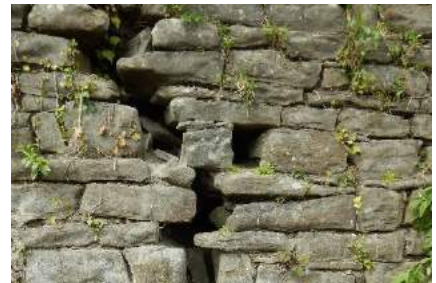
4.1.4.3 The cracks have promoted significant vegetation growth and are currently partially filled with roots, soil and other debris.

4.1.4.4 No evidence was observed to suggest these are actively moving and no structural causes were identified. This suggests the cracks are historic and potentially related to thermal movements from when the furnaces were active.

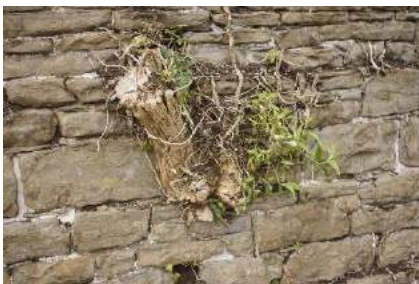
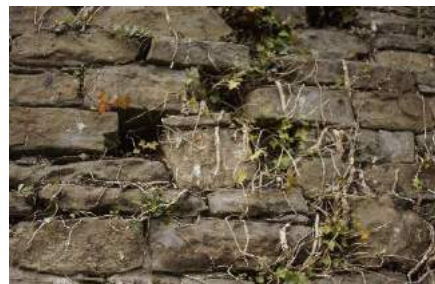
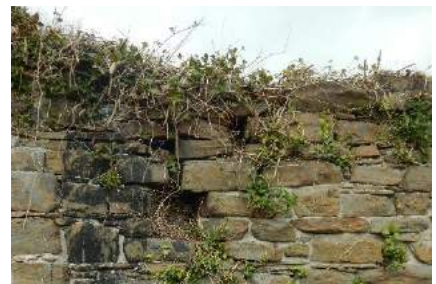
4.1.5.2 Generally, the vegetation growth has not visibly displaced the facing stonework with roots flattened and distorting through the joints. The main exception to this is the top section of the elevations where the vegetation growth in joints is prolific and the weight of stonework is less, here the vegetation has jacked the joints open and distorted the stonework.

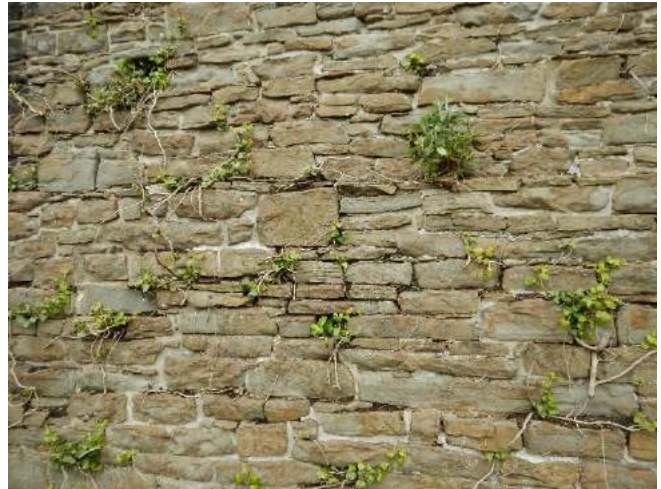
- 4.1.6.1 Pointing to both furnaces is very variable. There are two ages of pointing clearly visible, one probably from the 1995 works and one older. During the 1995 works patchwork repointing appears to have been undertaken over the whole of each face with no clear patination as to what was repaired. This pointing is recessed slightly from the face of the stonework and is generally in reasonable condition. The older pointing is visible in some locations recessed from the face and generally friable. The remainder of the joints are open or filled with soil and vegetation. No cement pointing was noted to any of the elevations.

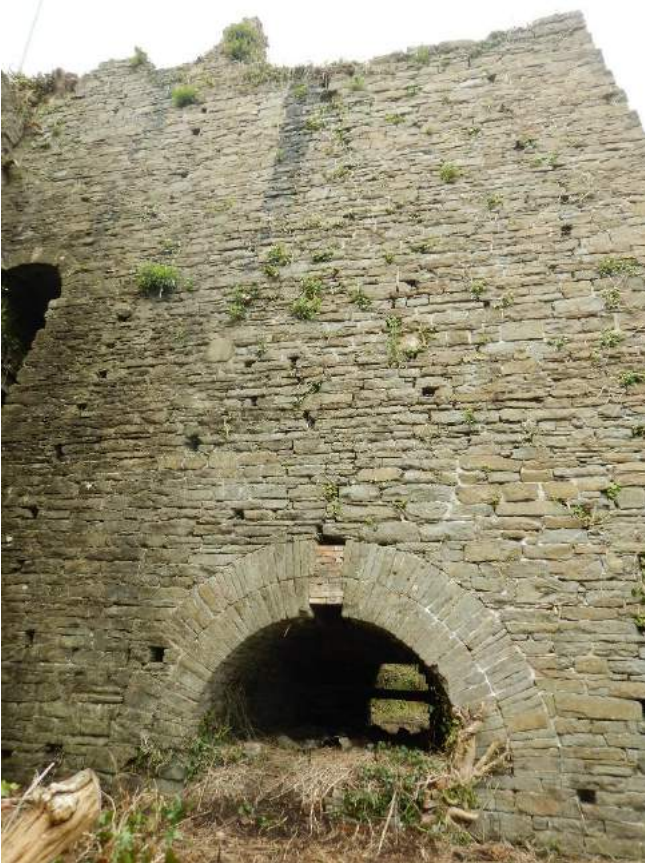
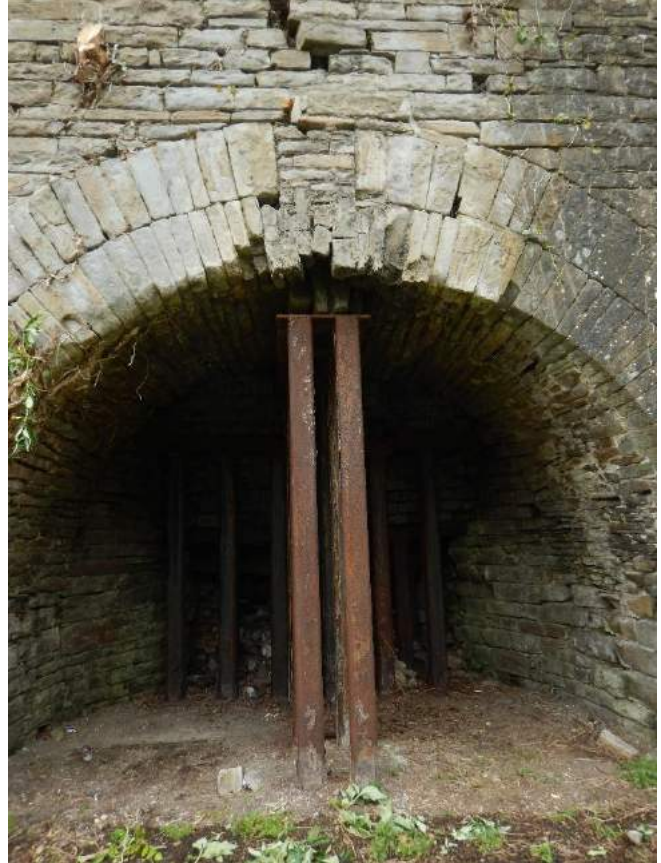
- 4.1.8.1 The two arched openings at ground level of furnace No1 have a historic defect at the keystone of the arch. The keystone is missing and has been replaced with stone or brick infill. The south elevation arch has missing stones at the crown the full depth but has only been infilled with a half brick skin in the facing arch. The east elevation arch has missing key stones in the facing arch and dropped stones at the crown of the arch for the remainder, these dropped stones have been propped with steel posts and the gap in the facing arch has been infilled with rubble stone.

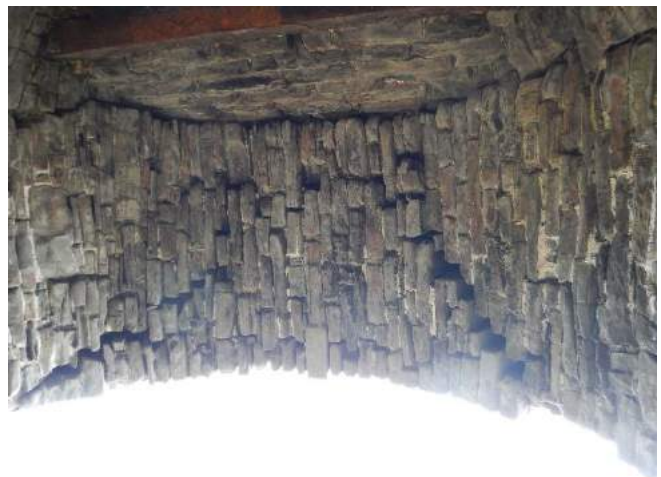
- 4.1.8.2 Both of these arches and the furnace No2 east face arch have significant cracks which appear to be a continuation of the large open cracks in the elevation faces. These continue through the arch soffit and the side walls of the openings. The arch in the east elevation of furnace No 2 is the most significant, a portion of this facing arch has dropped significantly between two cracks.

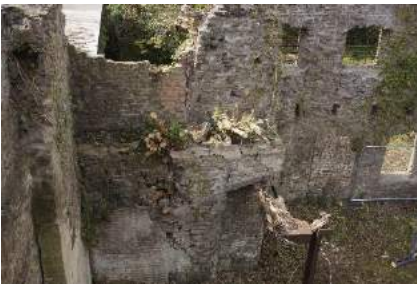
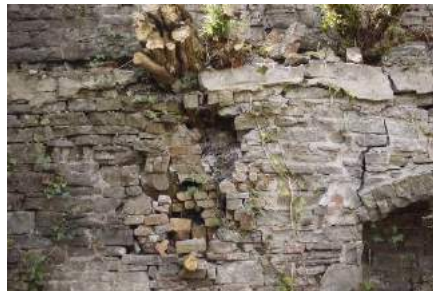
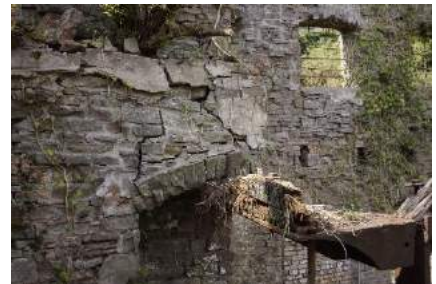
4.2.2.2 On the inside face of the west elevation there are two significant tree stumps on a shelf two thirds of the height of the wall. These have caused significant distress and disturbance to the masonry below. There is a large section of loose facing stonework just below one of the stumps and an unstable arch over a recess below the other. This portion of wall has a large section of brick facing which is likely a historic remedial repair, it is not mentioned on the drawings for the 1995 works so may predate this. Above the ledge the masonry is generally stonework with an inserted brick flue, this appears to have been consolidated and is in reasonable condition.

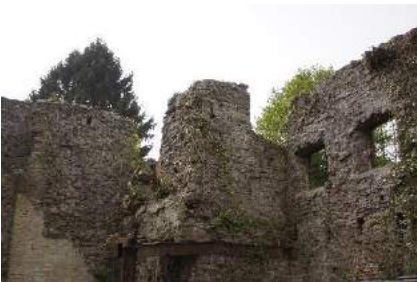
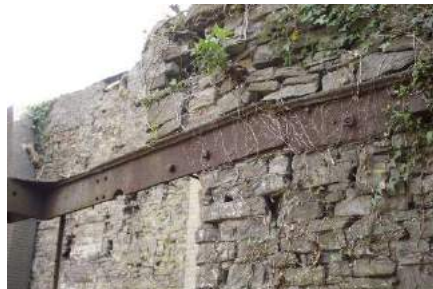
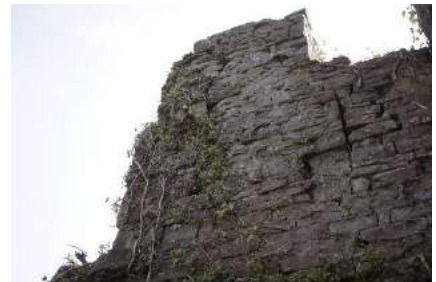
4.2.2.3 The inside face of the south elevation is in less distress. There is an area of loose masonry at high level adjacent to one corner and a straight joint with no tying at the other corner. There is also a cast iron beam embedded in the wall which supports the arch in the west elevation. This beam has failed in the wall and its free end is supported on an Accro prop.

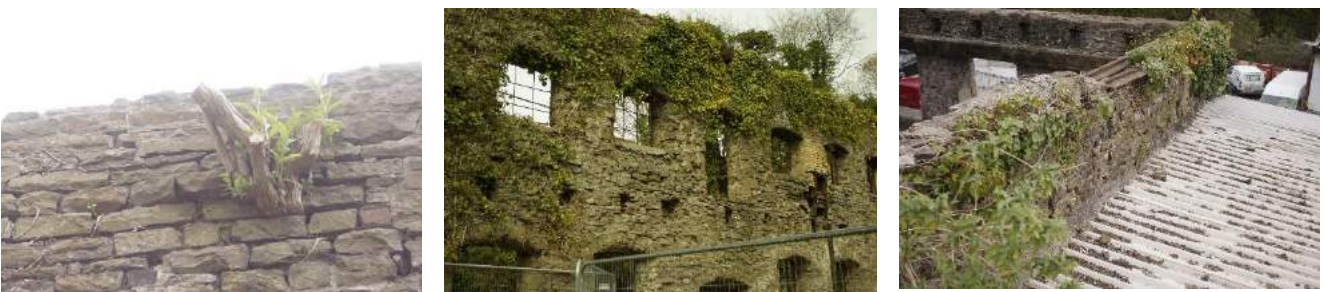
- 4.2.4.1 All elevations have the remains of significant vegetation cover. This has been cut back but some ivy cover and a number of stumps remain including some very large stumps. It is likely these have significant root systems which probably penetrate deep into the core material of the wall construction.
- 4.2.4.2 The larger roots have caused distress to the surrounding stonework by displacing stones and working some of them loose.
- 4.2.4.3 One area of significant distress is the south elevation above the adjacent building. In this area the abundant vegetation growth has displaced and loosened a significant portion of the outer stone skin.

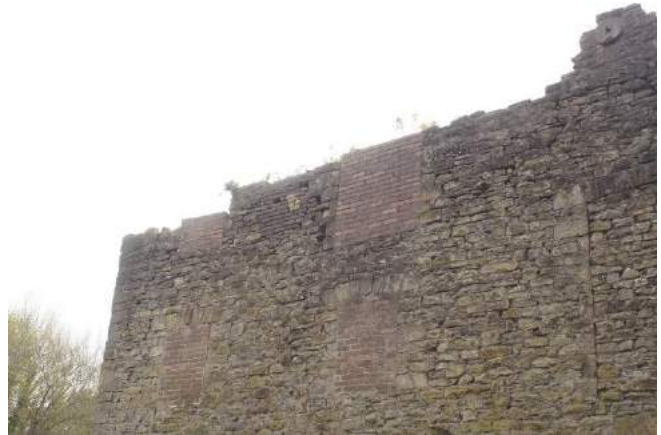
- 4.2.5.1 Where brick infill is present to the windows it does not appear to be tied into the surrounding stonework. Generally, this is not an issue but in locations where the windows have no head the brickwork can be manually deflected.

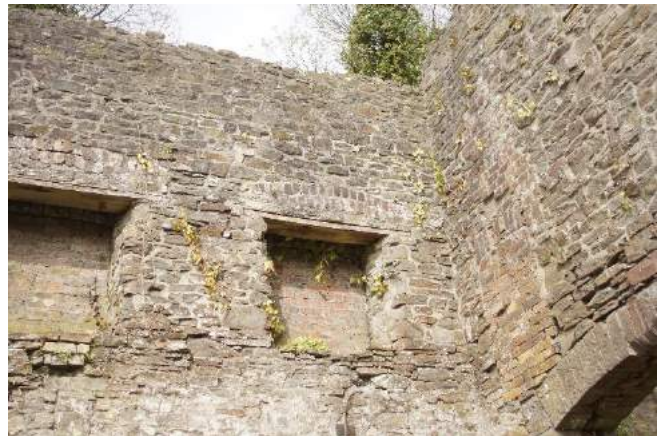
- 4.2.6.1 Generally, the condition of the pointing to all elevations of the manufactory is reasonable but variable. It is clear some repointing and rebuilding work was undertaken in the 1995 works. There are areas throughout the building where the pointing is missing or loose, the south end is slightly worse, but this is generally randomly distributed. No cement pointing was noted to any of the elevations.

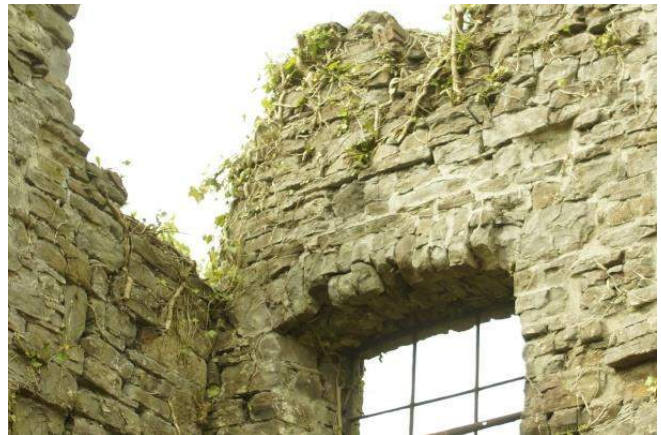
- 4.2.7.1 Some of the window arches have cracked and or loose stones. There does not appear to be any global distress to the arch or the surrounding masonry. This suggests the damage is the result of weathering or vegetation.

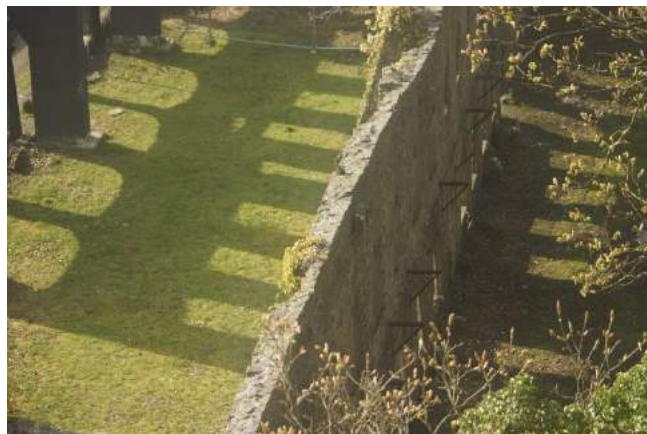
- 4.2.8.1 It is clear the wall heads were consolidated as part of the 1995 works and generally they appear to be in good condition. There are a handful of loose stones on the wall head.

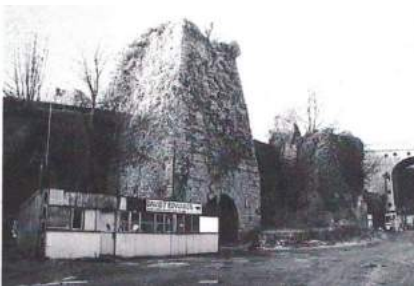
1984 image of furnace No2

5.3.1 The most significant and visual sign of distress is the large crack to the east elevation of furnace No2 and the similar but less significant cracks to the other elevations of both furnaces. From the observed evidence these cracks have been present for at least 35 years. The cracks have occurred roughly in the centre of each side where the construction is thinnest and are not visible on the inside of the furnaces. We believe these cracks are likely to have been caused by the temperature differential across the thickness of the masonry during cooling and heating of the furnace. In these conditions the inside would be hot, and the outside would be cool, expansion of the hot inside would generate tension forces in the outside face. If this is correct it is likely the cracks appeared relatively soon after construction and have been more or less stable for over 200 years.
