Monitoring on-farm egg impact to improve efficiency

February 2020

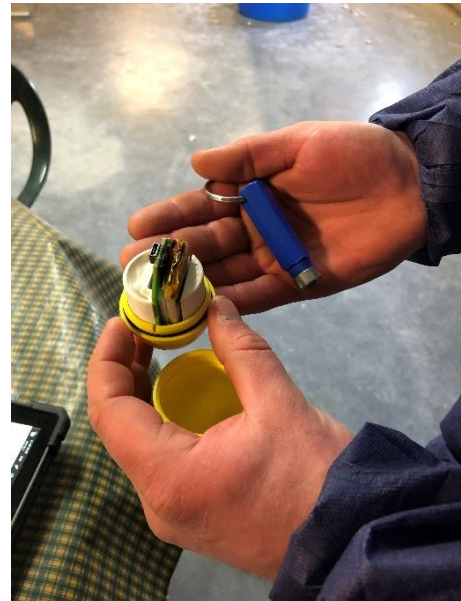
Figure 2. Inside the CracklessEgg™ device are sensors

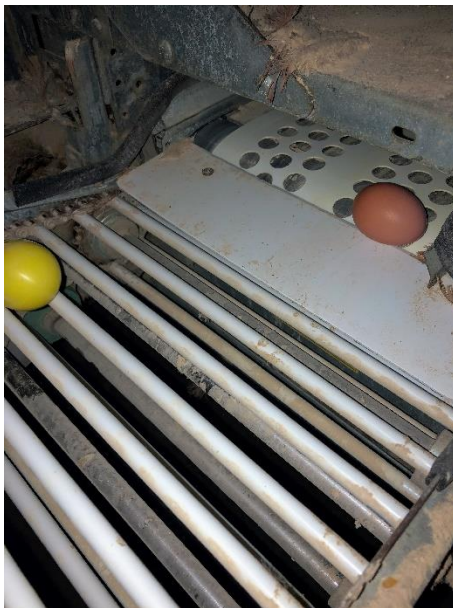
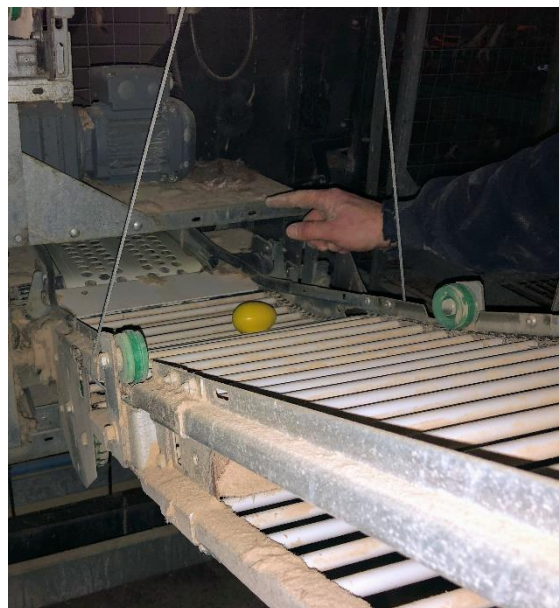
Figure 13. Device on first transfer point

Figure 4. Device on first transfer point

The CracklessEgg™ was placed on the egg belt and moves through the transfer onto the second belt where it rises to the cross transfer. This was done multiple times to gather a representative reading. The CracklessEgg™ measures the force in real time to gauge where issues are.

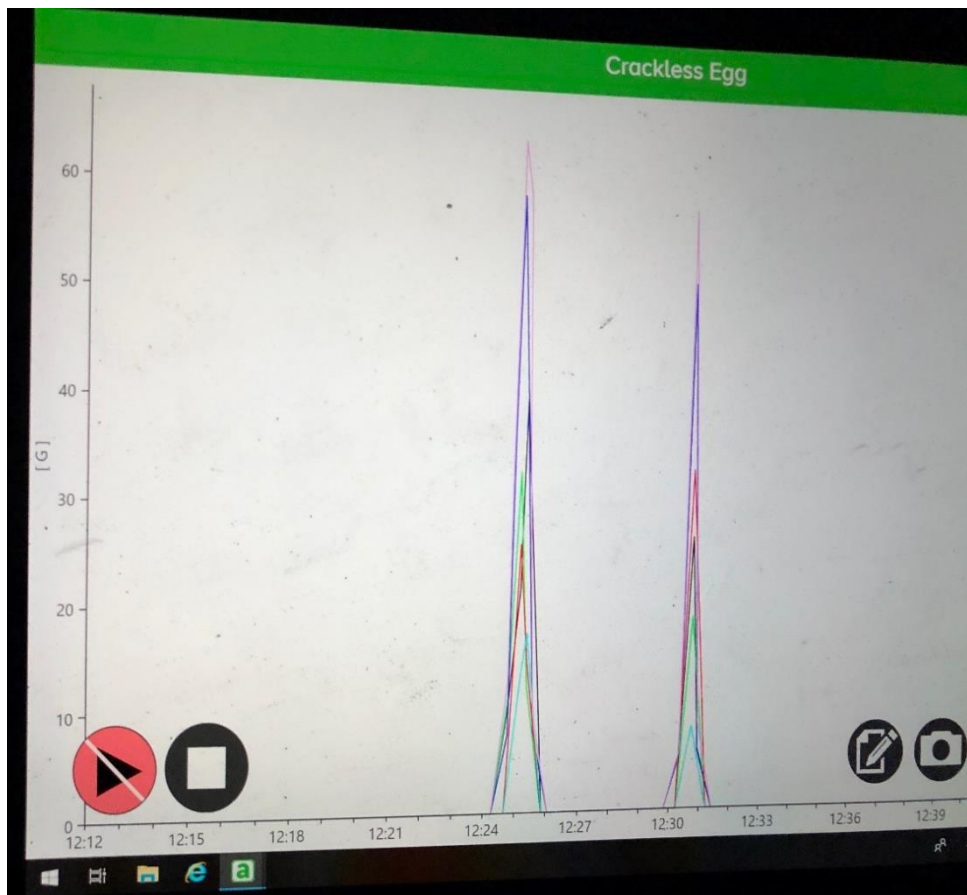
Figure 5. Results on first transfer point

The initial reading showed up to 60 (G) which indicates an area where shell cracking could occur. Issues that can cause this are that the angles of the join are too high, a sagging or uneven belt, or too high belt speed. It was felt in this situation that the angle was correct, however, there was too much sagging on the belt. This was tightened manually resulting in a reduction in the reading.

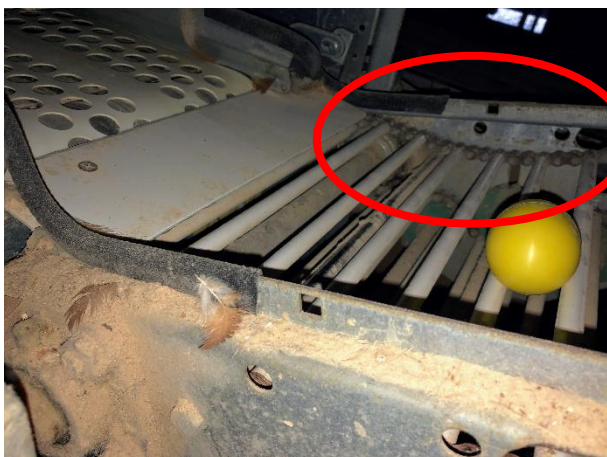
Figure 6. Sag in belt on transfer point 1

Figure 7. Osian tightening the belt

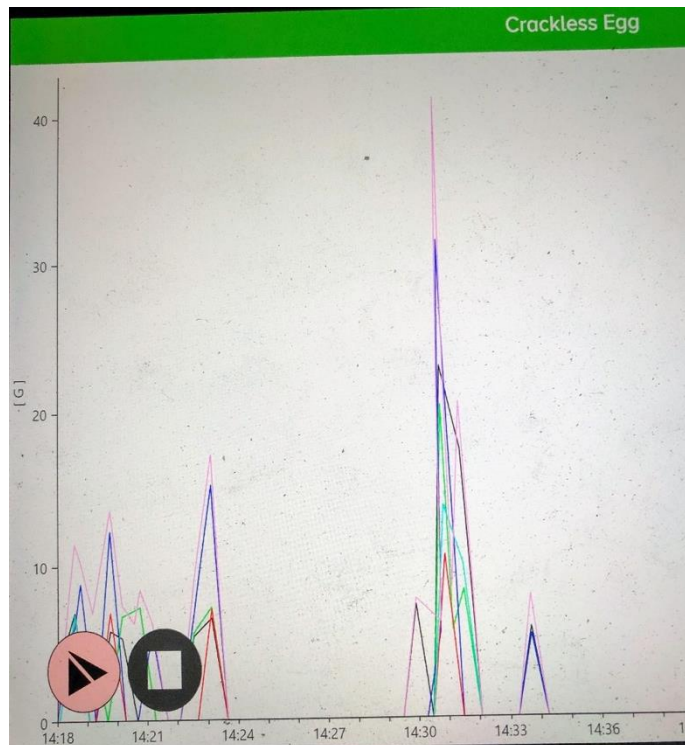
Figure 8. Results on transfer point 1 following first adjustments

The second reading showed a reduction to 40 (G) due to tightening the belt manually. It was felt that this reading could be reduced more by removing one of the links from the belt which Osian will do after the visit.

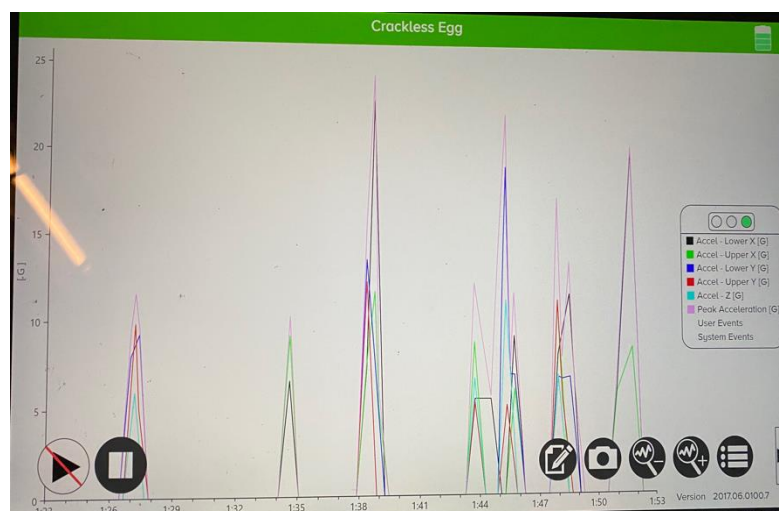
On 24 February, a second visit with the CracklessEgg™ was carried out after Osian had made a few more minor alterations, including removing one of the links from the belt as was previously recommended. This resulted in a decreased impact to eggs of approximately 20 (G).

Figure 9. Results on transfer point 1 following second adjustments

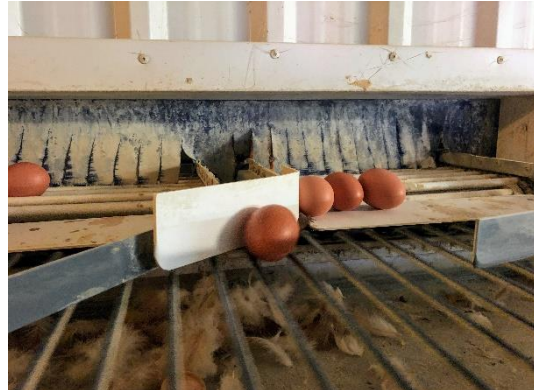
Figure 11. Plastic deflector positioned to reduce impact

This area was tested second on 5 February, however, there were no issues on the transfer between the transfer belt to the cross transfer into the packing area. We tested another section of the belt on our second visit on 24 February and identified one area where improvements could be made. This was improved by placing a plastic deflector on the belt to reduce the impact.

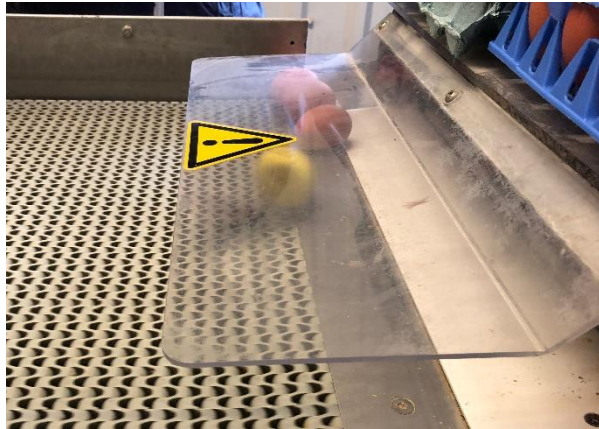
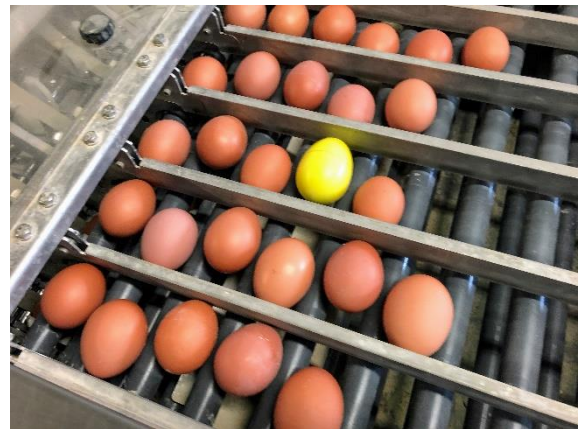
The CracklessEgg™ showed that there were some areas for concern where the eggs moved into the separator due to banging. Osian replaced the dividers with slightly narrower ones which reduced the impacts. He also ran the belt at a slower speed

Figure 12. Device on egg packer

Figure 13. Device on egg packer

(which he would do normally) and this also reduced the spike levels to acceptable (20-30 (G)).

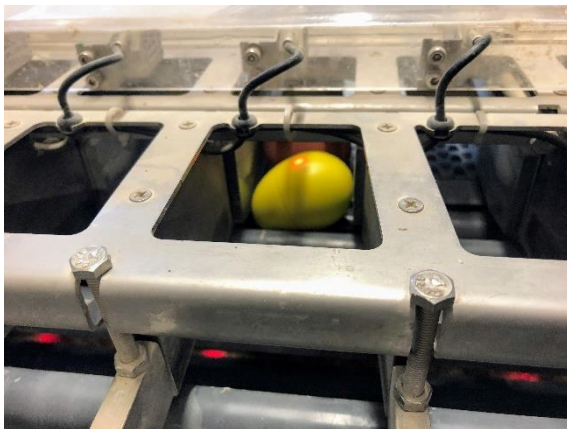
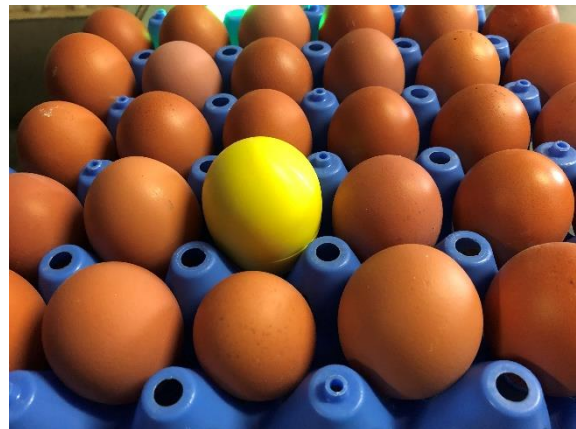
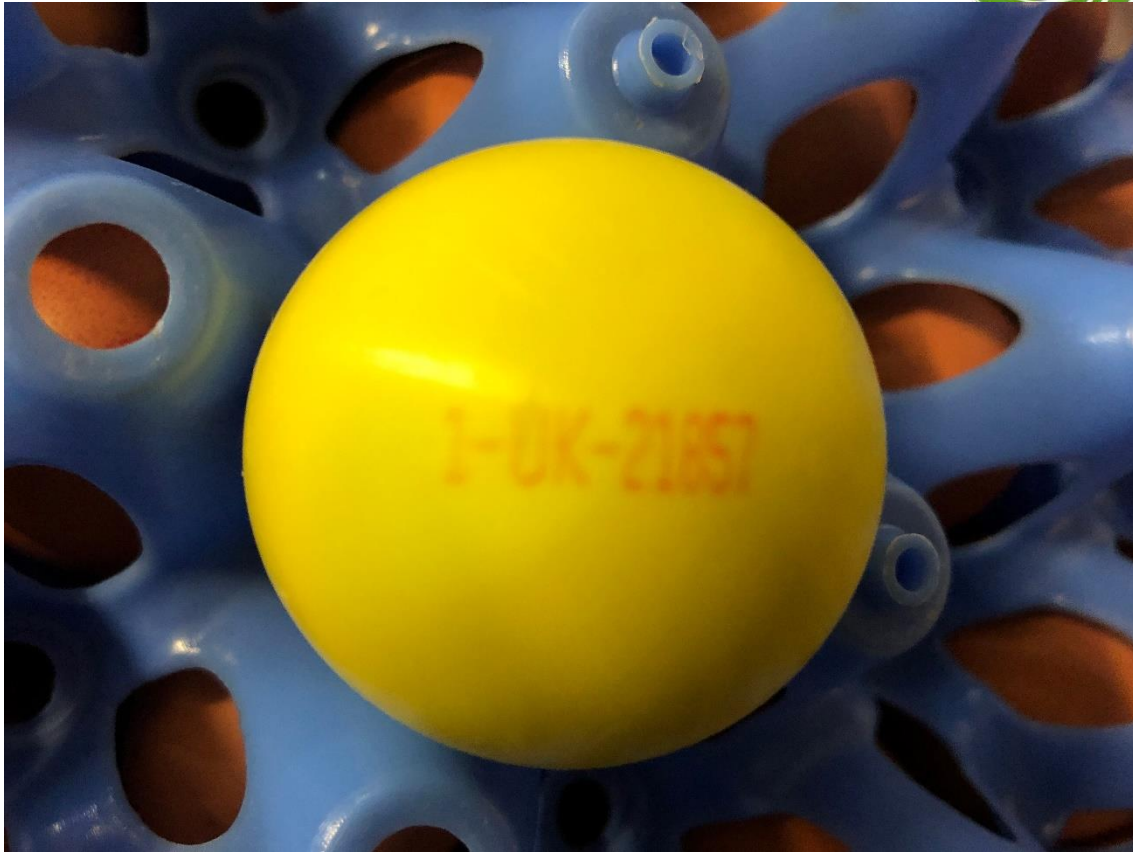
Figure 14. Device at tray transfer

Figure 15. Device in tray post transfer

Figure 16. Device in tray post transfer with stamp

When the CracklessEgg™ went through the packing area and machine it showed no areas of concern and the real-time data showed acceptable levels of stress which would not result in cracking, therefore, no further alterations were required at this area.

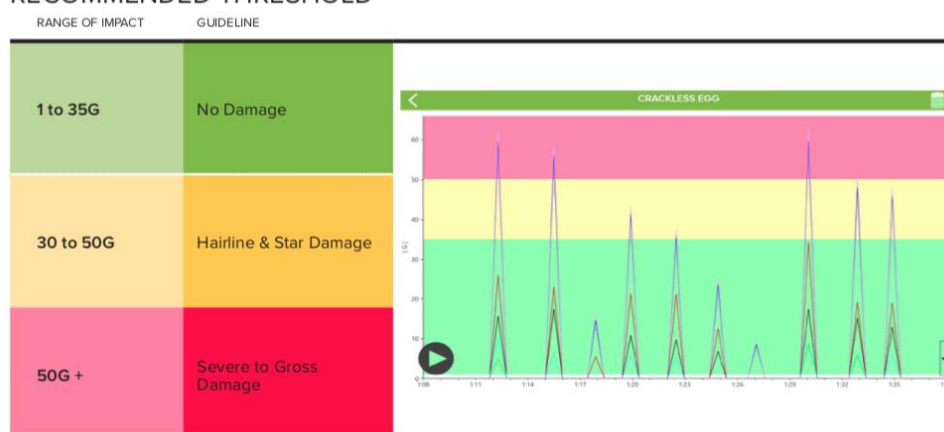
Table 2 (Crackless Egg Guide 2017, Version 2)

- Belt speed plays a big part in damage and hairline fractures, see table 2 below. Speed is often turned up at the end of the day in sheds as egg collectors want to get them through quicker as there are less eggs coming through, but this is when cracks and damage are most likely to occur.
