Neath Abbey Ironworks Community Evaluation, Neath Port Talbot

Archaeological community evaluation

July 2019

A report for The Friends of Neath Abbey Iron Company By James Toseland BA GGAT report no. 2019/033 Project no. P1975 National Grid Reference: SS 73820 97738

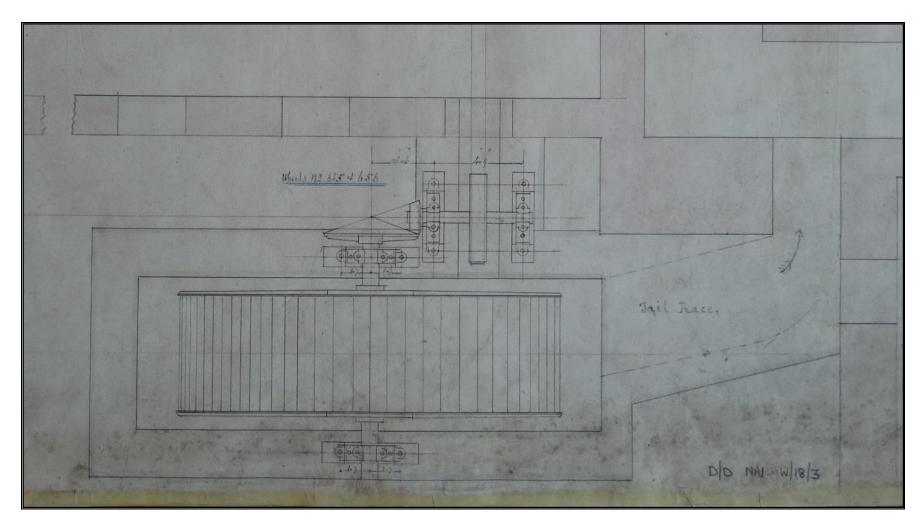
The water wheel uncovered in the evaluation works is depicted on contemporary plans dating to 1928; some sources suggest it might be 1878 (Plate 1). The purpose of the wheel was for driving fitting shop machinery. The power was fed through an existing door in the west facing elevation.

Plate 1. Detail from plan of water wheel (Copyright West Glamorgan Archives)

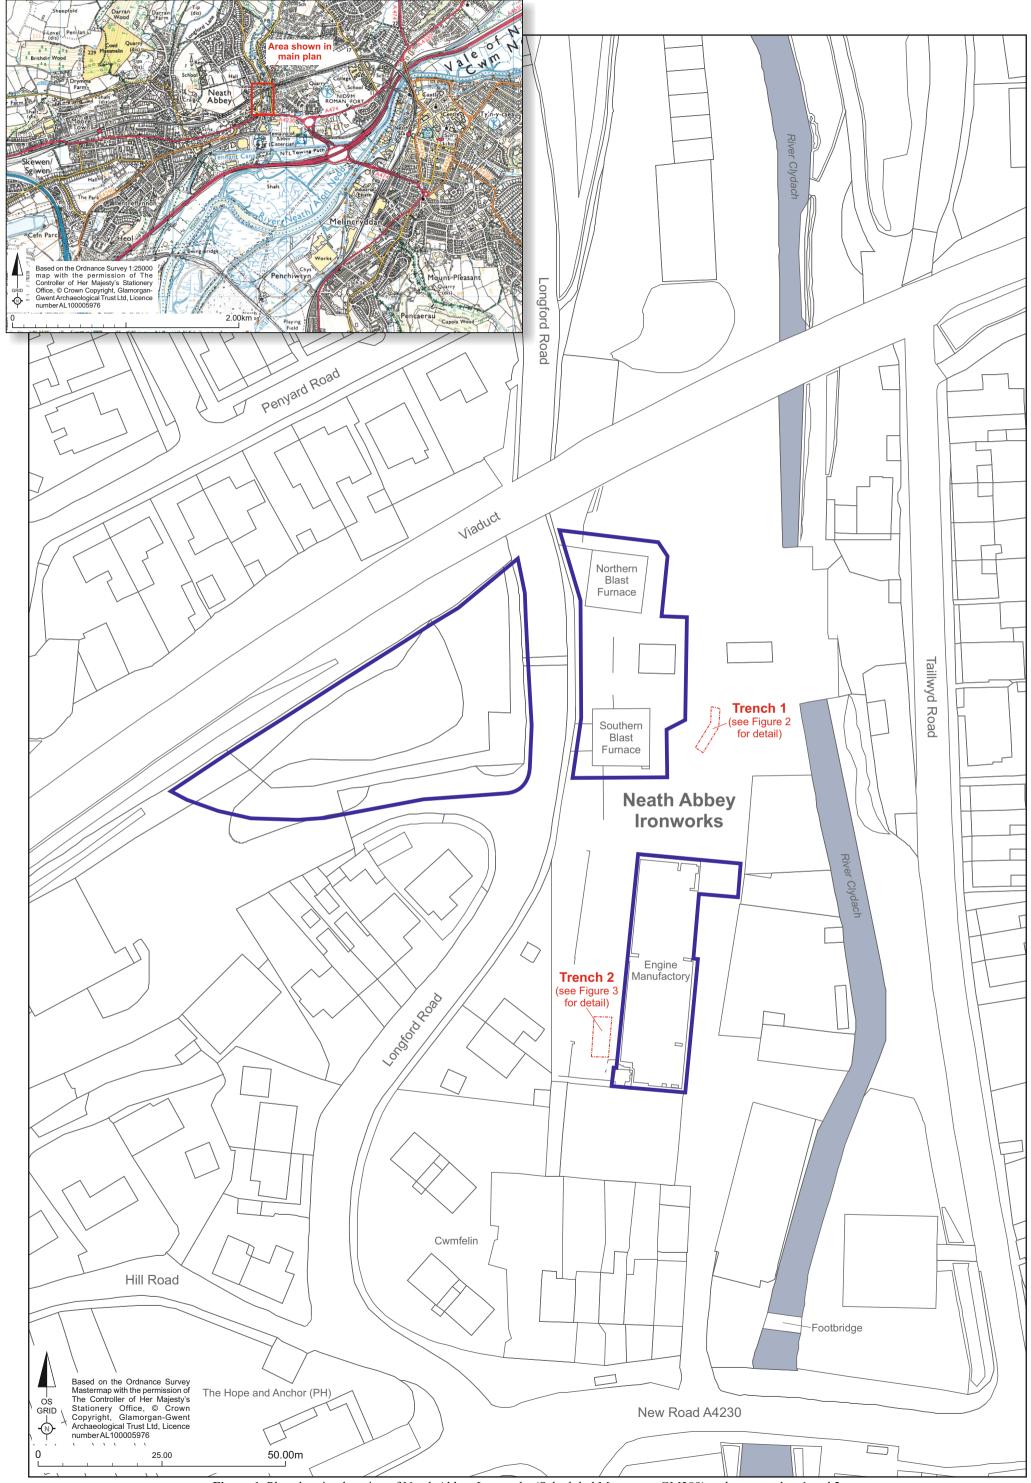
Figure 1. Plan showing location of Neath Abbey Ironworks (Scheduled Monument GM389) and test trenches 1 and 2.

The two trenches were located one over the Southern Blast Furnace area (Trench 1) and Trench 2 over the Manufactory area.

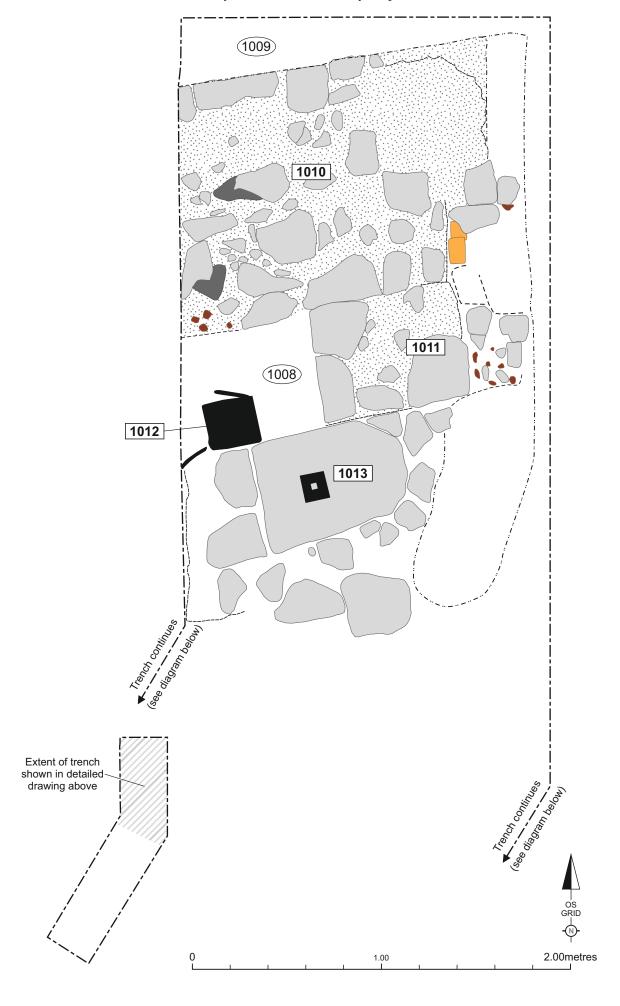
Figure 2. Trench 1. Plan of Casting-house structures.

Southern Blast Furnace area – Trench 1 (Figure 1 and 2) measured 6m by 3m and consisted of a single slot trench orientated southwest/northeast to establish the extent and nature of any archaeological remains located to the east of southernmost blast furnace. This trench was then extended at the northeast end to capture the casting house wall.

Trench 1 revealed remains of the casting house. The north wall of the casting house (1010) measured 1.34m in width and was aligned east-west (plate 1). The wall constructed of lime-mortared rubble had been truncated to 0.15m below current ground level. Abutting 1010 to the south was a rectangular masonry structure (1011) measuring 0.6m by 0.74m (plate 2). To the south of 1011, a large stone measuring 0.56m by 0.76m contained an iron mounting (1013) (plate 3). The mounting measured 0.125m square and contained a circular 60mm hole. Abutting 1010 to the north was a hard black metalled surface (1009).

Inside the casting house stratigraphic deposits consisted of layers of sand. The basal deposit (1007) was dark brown silty sand with charcoal flecks encountered at 0.82m below ground level. This was overlain by deposit 1006 a 0.07m thick mixed sandy silt with light sand inclusions. Overlying 1006 was a 0.49m thick dark brown sandy silt with inclusions of slag and large iron lumps (1005); this deposit also overlaid 1010, 1011 and 1012.

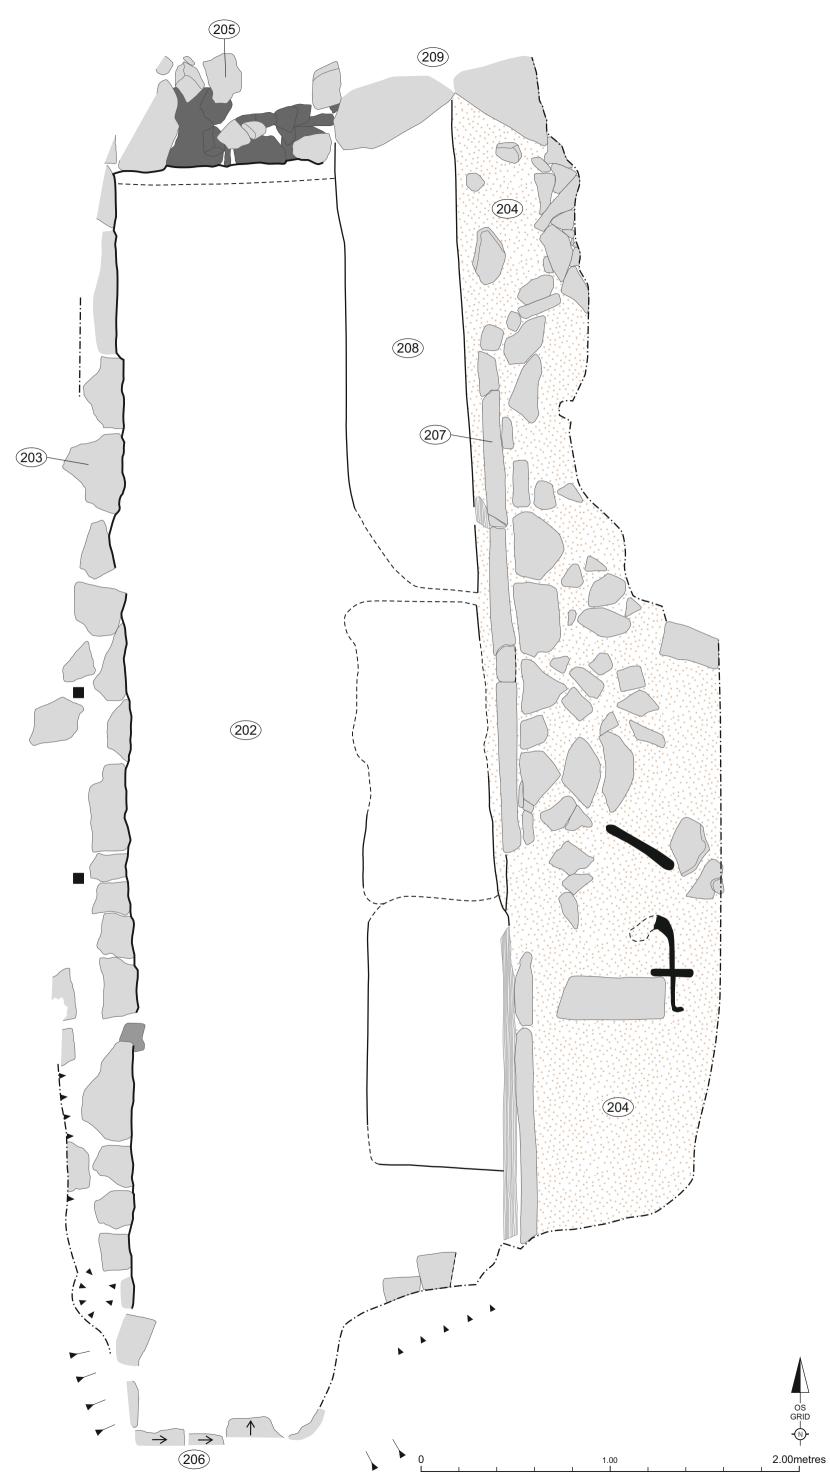
Figure 3. Trench 2. Plan showing the wheel pit.

Manufactory area –Trench 2 (Figure 1 and 3) was excavated to the west of the former engine manufactory in order to identify the nature and extent of any surviving remains associated with the wheel pit that housed the wheel that provided power to the manufactory around 1844; this wheel pit is shown on engineering drawings of the period.

Trench 2, which revealed the location of the wheel pit comprised a basal deposit of bedrock (209). The bedrock, which was exposed to the north of the wheel pit, had been cut (210) to create the wheel pit. The bedrock was cut vertically, with evidence of a drilled hole (plate 4) to indicate how the cut was achieved. Four masonry walls (203, 204, 205 and 206) formed the wheel pit; the upper courses were missing throughout as was a section of the wall in the north-east corner exposing the cut in the bedrock (210). The two long walls (203, 204) of the wheel pit each had an internal length of 6.7m and both incorporated a pair of iron mounting pins. The pins had a 40mm square cross section and a circular threaded end were 0.92m apart. Two further mounting pins; 0.9m apart and at ninety degrees to those exposed; were noted on the east side of the wheel pit but were not excavated.

The north wall of the wheel pit (205) was built abutting the natural bedrock 209 and wall 203 (plate 5). The eastern portion of 205 was truncated with only a 1.05m length surviving at the upper excavated levels. Wall 205 of which 0.55m was excavated sloped inwards rather than to the vertical.

The south wall (206), of which 0.5m in height 0.7 in length was excavated, was bonded into wall 203 (plate 6); the junction between 206 and 204 was not excavated due to the proximity of the scheduled monument walls.

The east wall (204) was abutted on the internal west facing elevation by a modern block wall (207) which was in turn abutted by a concrete floor (208) (plate 7). The wheel pit

was excavated to approximately 1m below ground level stopping at the uppermost level of a concrete floor, 208. The area between the walls was infilled with dark brown silty clay containing modern concrete blocks and masonry rubble (202). The uppermost deposit was a clay loam containing frequent roots (201).

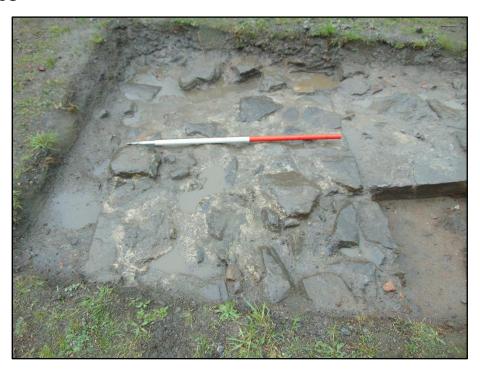
During the course of the excavation, Trench 1 located the remains of the north wall (1010) of the casting house; the remains were relatively shallow and appear to have been demolished to ground level. A question arose as to whether the north wall represented the base for an open sided building, but it remains unclear. The function of structure 1011 abutting wall 1010 is also unclear, but may be a base/support for roofing or other internal structure. Feature 1013 is possibly part of a crane base. The floor of the casting house, in the area examined, was made up of thick layers of sand, presumably casting sand.

Plate 2. Trench 1. Wall 1010-north wall of casting house, view to east (scale 0.5m divisions)

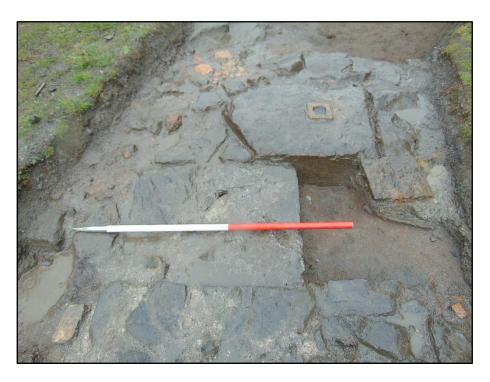
Plate 3. Trench 1. Structure 1011 abutting wall 1010, view to south (scale 0.5mdivisions)

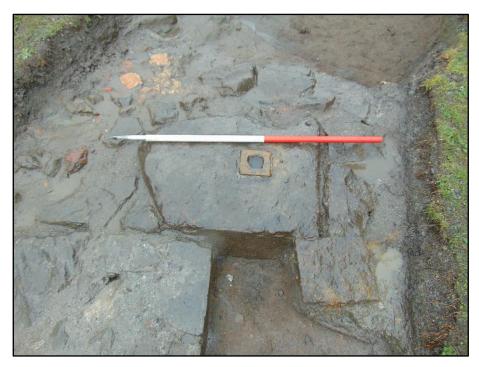
Plate 4. Trench 1. Structure 1013, possibly part of a crane base. View to south (scale 0.5m divisions)

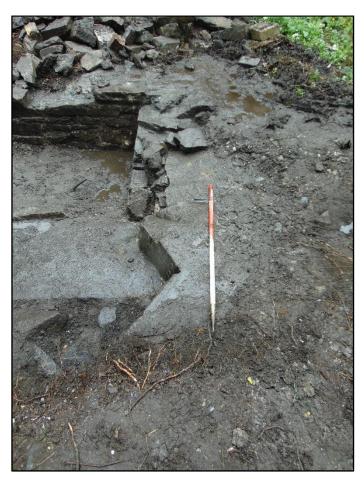
Plate 5. Trench 2. Cut 210 in bedrock 209. View to west (scale 0.5m divisions)

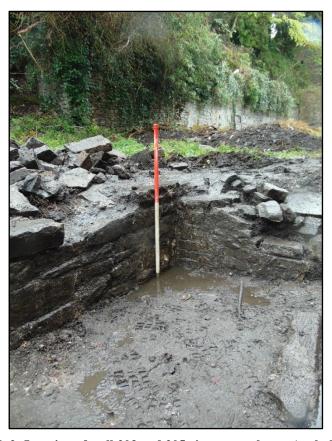
Plate 6. Trench 2. Junction of wall 203 and 205 view to northwest (scale 0.5m divisions)

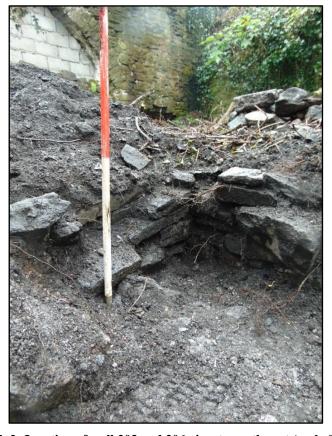
Plate 7. Trench 2. Junction of wall 203 and 206 view to southwest (scale 0.5m divisions)

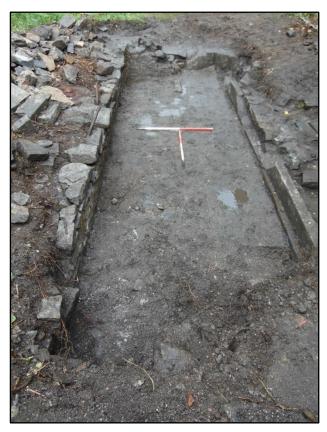
The upper courses of masonry in Trench 2, those over the wheel pit were missing, but the general level of preservation otherwise was good. It was also found that the wheel pit, at least its northern part, had been cut into solid bedrock. The east and west walls, incorporating the mounting pins, and possibly the south wall (206) were then constructed. The northern wall 205 with its sloping face appeared to have been built abutting the west wall and probably the east wall; although the east and north wall junction was not excavated.

The wheel pit appears to have been re-used in the second half of the 20th century with the insertion of a blockwork wall along its east side and the addition of a concrete floor. The purpose of this later structure is unclear although suggestions include a vehicle inspection pit. The later structures within the wheel pit may suggest the wheel pit was at least partially open and visible when they were inserted.

Plate 8. Trench 2. General view of wheel pit. View to north (scale 0.5m divisions)
