Neath Abbey Ironworks

Summary of Structural Investigation

The Friends of Neath Abbey Iron Company

Project Number: 9446

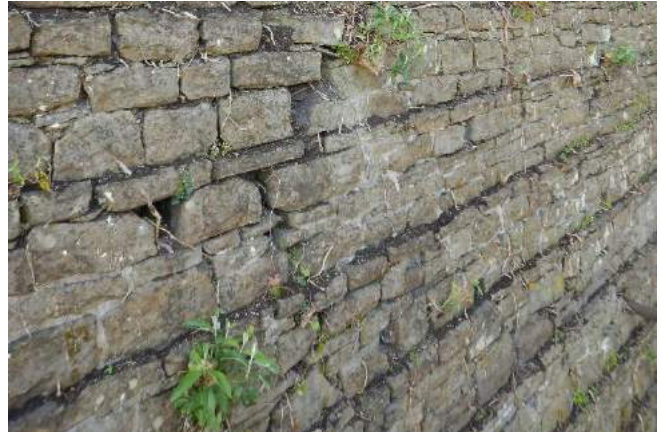
3.1.1 The faces of both furnaces are formed from well coursed rubble stone with large stone quoins particularly at low level. The raked walls are formed from distinct steps coinciding with shallower stone courses. There are vertical lines of putlog holes in all of the elevations. The stonework at the top of both furnaces is ruinous suggesting they were originally taller than the current remains.

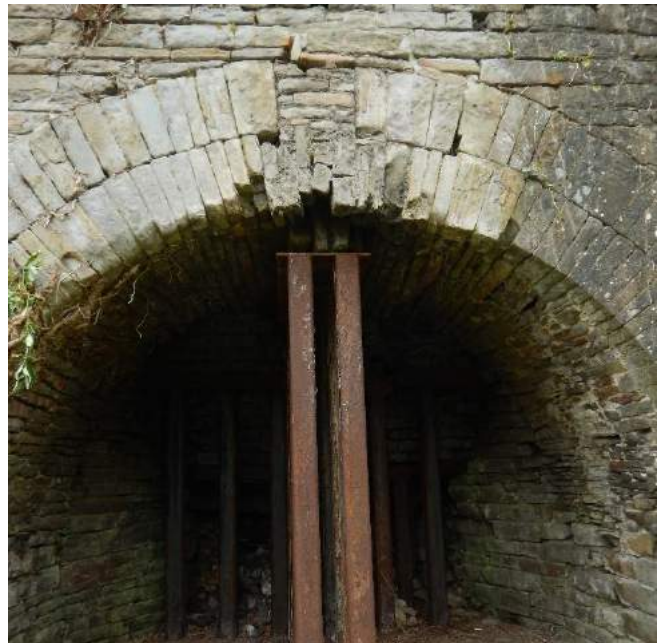
3.1.2 There are arched openings at the base of the furnaces in some elevations. These vary in size and position but are all semi-circular with two courses of stone in the facing arches. The stone facing arches are formed from 450-500mm deep rectangular stones. Inside the facing arch the opening continues in the same profile perpendicular to the face for 2m. The walls and soffit then taper into a small opening to the furnace. These openings are blocked in furnace No 2. The tapered soffit is formed from corbeled stonework and a series of cast iron beams. These openings would have formed the hearth and tuyere pipe openings into the furnace.

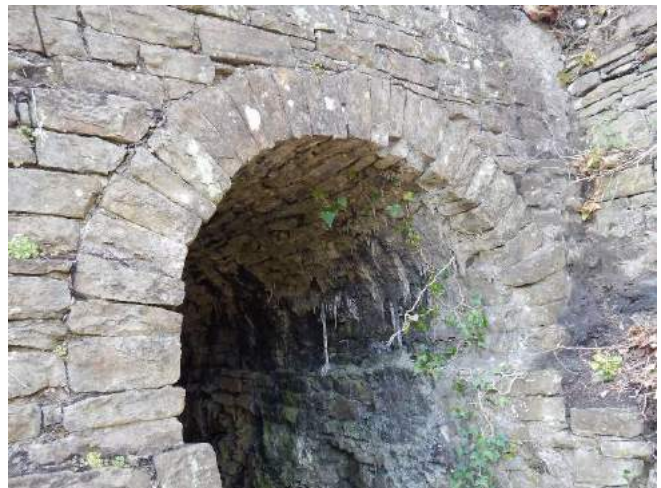
3.1.3 The arched soffit between the west elevations and the cliff are also semi-circular but with one course of stone in the facing arches. The stone in the facing arch is slightly tapered in shape.

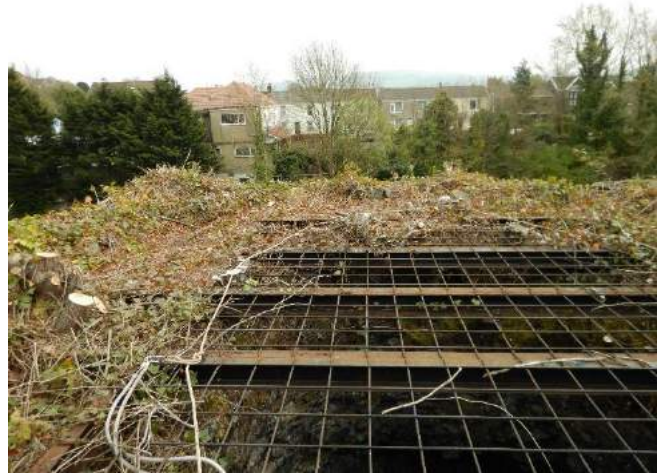
3.1.4 On top of both furnaces is a steel frame over a circular opening to the inside. The frame is formed from back to back steel channels and covered with a welded reinforcement mesh.

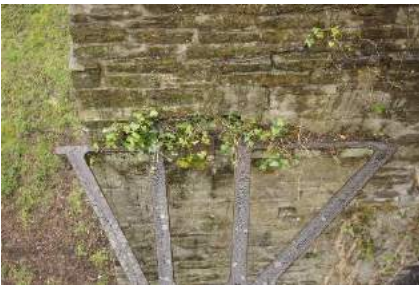
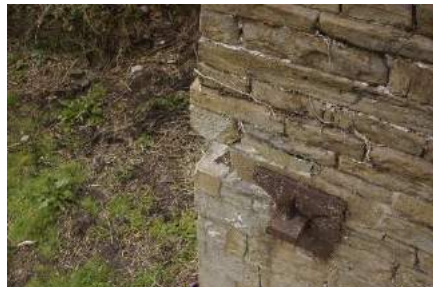
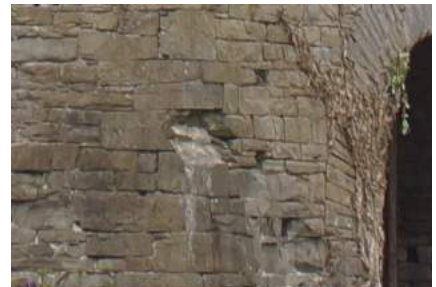
3.1.5 There are various scars and remnants of previous structures built into the furnaces. There are large cast iron brackets at about 4m above ground level and there are remains of arch springing on the east elevations of both furnaces.

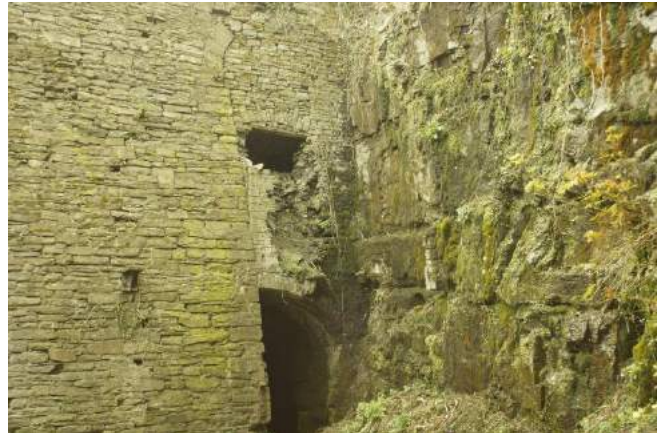
3.2.1 Blast furnace No 1 has a square base approximately 11.5m to a side with a 2m gap to the cliff from the west elevation. It is 14m high with walls which are vertical up to 4.5m above ground level and then slope in by 1.5m to the top. At 8m above ground level the west face arches to the adjacent cliff for the full width of the west elevation. At 3.5m above ground level there is a lower arch between the west face and the cliff, set back from the north and south elevations by 2m. The volume between the two arches appears to be filled. At the north end of the west elevation the set back of the lower arch is infilled with a half arch. The top of the furnace is roughly 1m above Longford Road with a further 1m step up above the west face.

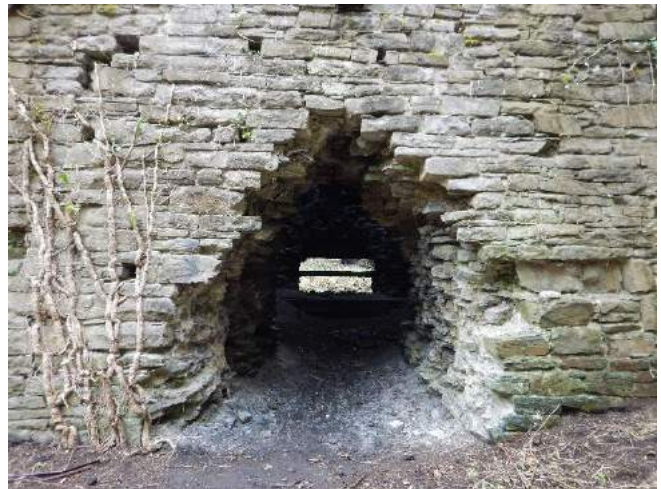
3.2.2 At the base of the furnace there are arched openings in the east and south elevations and a rough opening in the north elevation. The south arched opening is 3m wide and 2.5m high. The east arched opening is 4.5m wide and 3m high. The north rough opening is 3m wide and 3.5m high.

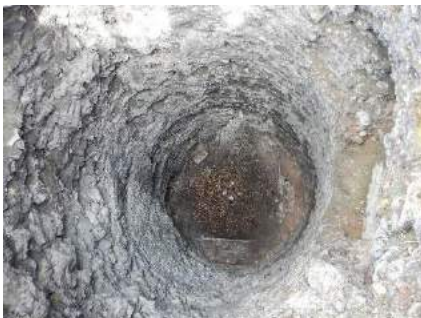
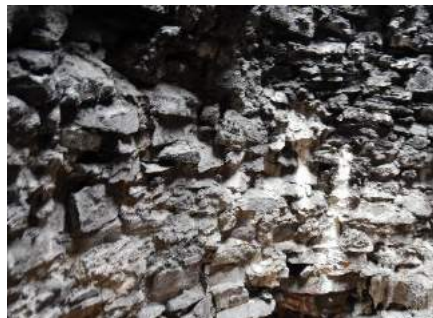
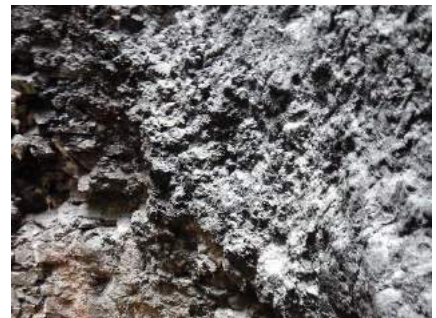
3.2.3 Inside the furnace is a roughly cylindrical void approximately 4m in diameter accessible at ground level through the rough opening in the north elevation and visible through an opening in the top. The surface of this inside face is rough stonework with a potentially cementitious build-up on the inside. The void appears to taper slightly in towards the top but the exact shape was difficult to determine.

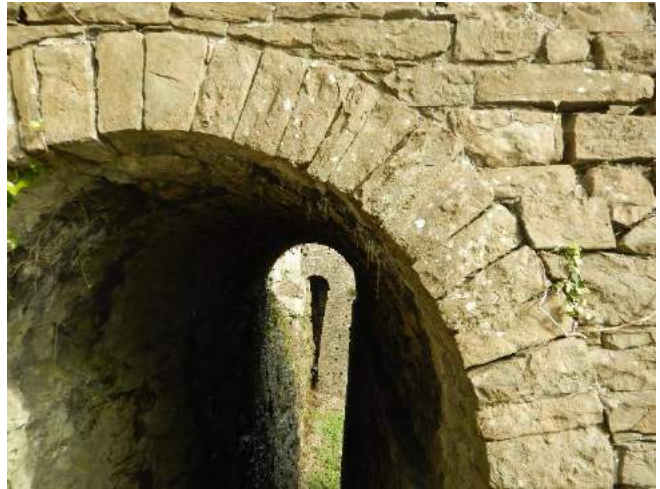
3.3.1 Blast furnace No 2 has a square base approximately 11.5m to a side with a 1m gap to the cliff. It is 19m high with walls which are vertical up to 4.5m above ground level and then slope in by 2m to the top. At 10m above ground level the west face arches to the adjacent cliff. The top is roughly 6.5m above Longford Road with a lower section adjacent to the road.

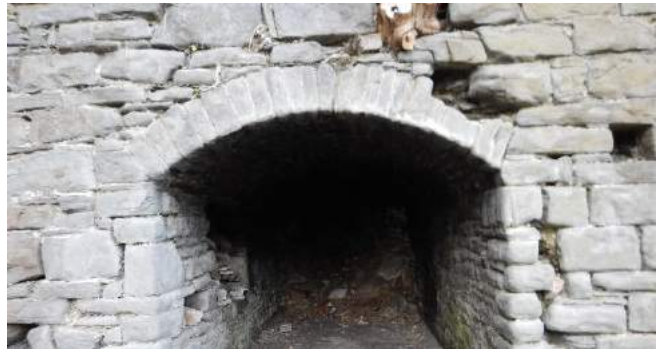
3.3.2 At the base of the furnace there are arched openings in the east, north and south elevations. The south arched opening is 2m wide and 2m high, this is different to the other openings not being semi-circular and only having one course of stone in the facing arch. The east arched opening is 4.5m wide and 4m high. The north arched opening is 3m wide and 3.5m high.

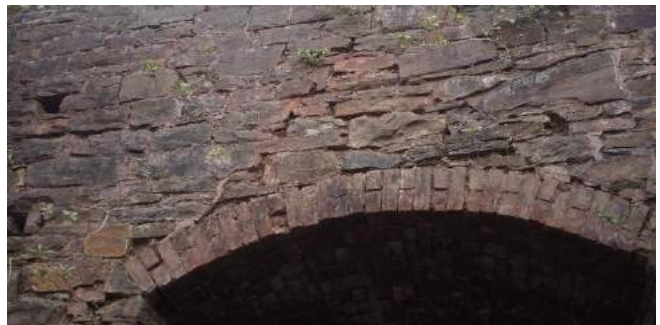
3.3.3 At Longford Road level there is an arched opening in the west elevation, it is 2.5m wide and 3m high. This arch is not semi-circular and only is formed from brick with a 1 brick thick facing arch.

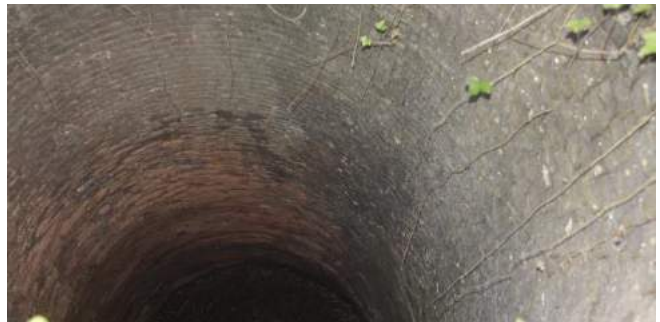
3.3.4 Inside the furnace is a cylindrical void approximately 4m in diameter only visible through an opening in the top. The surface of this inside face is brick.

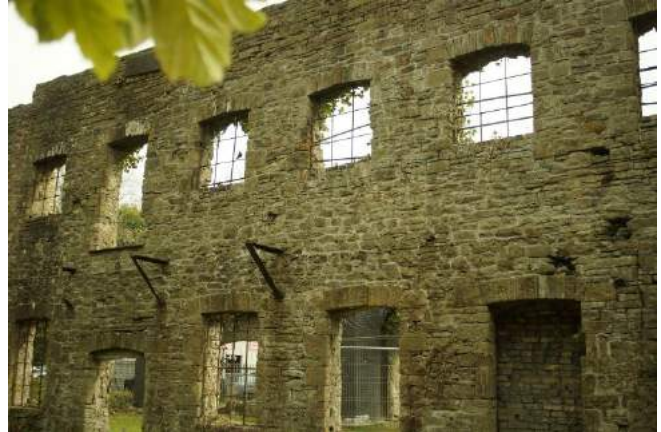
3.4.3 The walls are formed from well coursed rubble stone 600mm thick. This suggests two skins of facing stone with a core between. Many repairs and alterations have been inserted in brick including chimney flues and blocking openings.

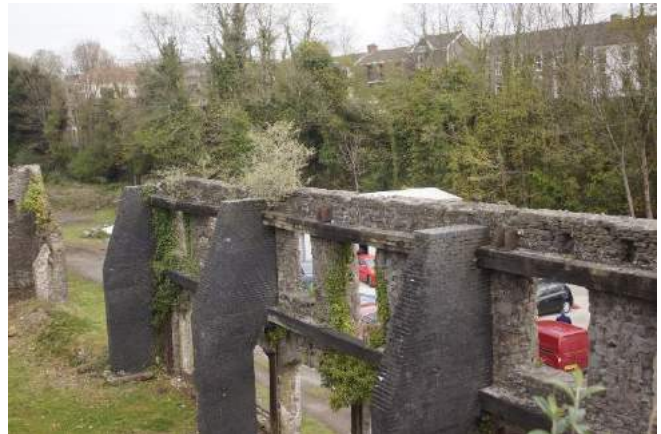
3.4.4 The east elevation has a series of brick clad concrete piers with timber horizontal beams between them to the internal face. There is also one pier to the inside face of the north elevation. These were found to be similar to the drawn proposals from the 1995 works and are assumed to be providing lateral restraint to the elevations.

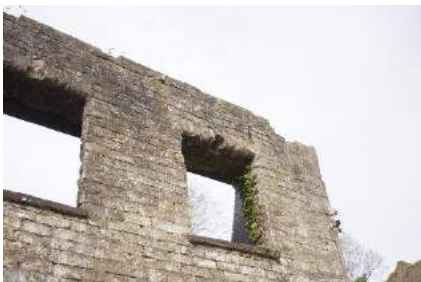
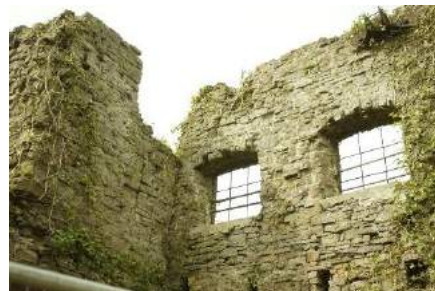
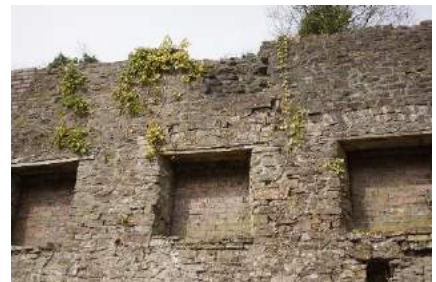
3.4.5 Window openings are generally at very regular centres. In the southern portion they are formed with through thickness stone arches, at ground level in the east elevation they are double width. In the northern portion they are formed with facing stone arches and internal brick relieving arches over timber lintels. These timber lintels were replaced in the 1995 works. Some of the openings have been bricked up.

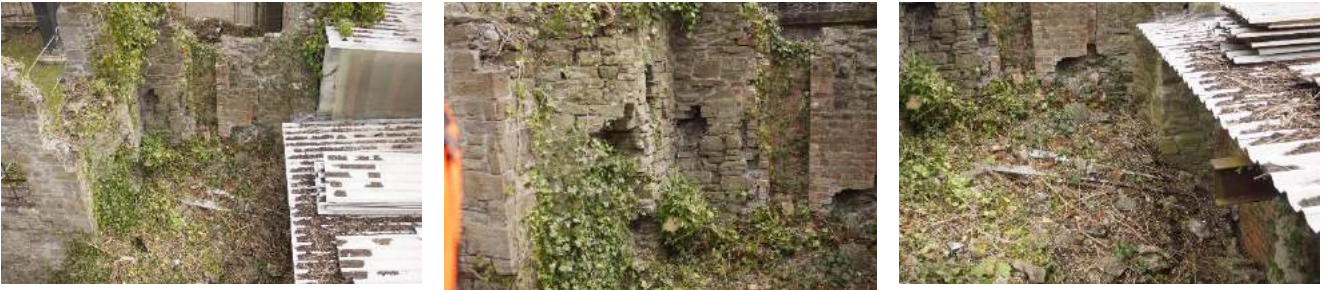
- 4.2.2.4 On the outside ground level is locally raised to just below the shelf on the internal west elevation. This is partially formed from an outcrop of bedrock but also has an arch in its face near ground level. Historic drawings show this to be the site of a waterwheel to power machinery within the engine manufactory and the arch is almost certainly part of a culvert to direct water. There is a large stump on the raised area.
- 4.2.2.5 The external walls are generally stone and roughly 500mm thick although as mentioned above there is a brick flue built into the west wall. This flue is for a section only half a brick thick. There are a number of sections of missing facing to the stone and brick sections, generally close to ground level.

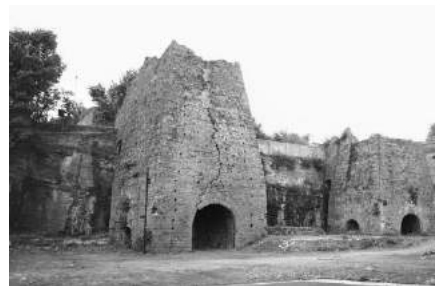
1994 Image of both furnaces

5.3.1 The most significant and visual sign of distress is the large crack to the east elevation of furnace No2 and the similar but less significant cracks to the other elevations of both furnaces. From the observed evidence these cracks have been present for at least 35 years. The cracks have occurred roughly in the centre of each side where the construction is thinnest and are not visible on the inside of the furnaces. We believe these cracks are likely to have been caused by the temperature differential across the thickness of the masonry during cooling and heating of the furnace. In these conditions the inside would be hot, and the outside would be cool, expansion of the hot inside would generate tension forces in the outside face. If this is correct it is likely the cracks appeared relatively soon after construction and have been more or less stable for over 200 years.

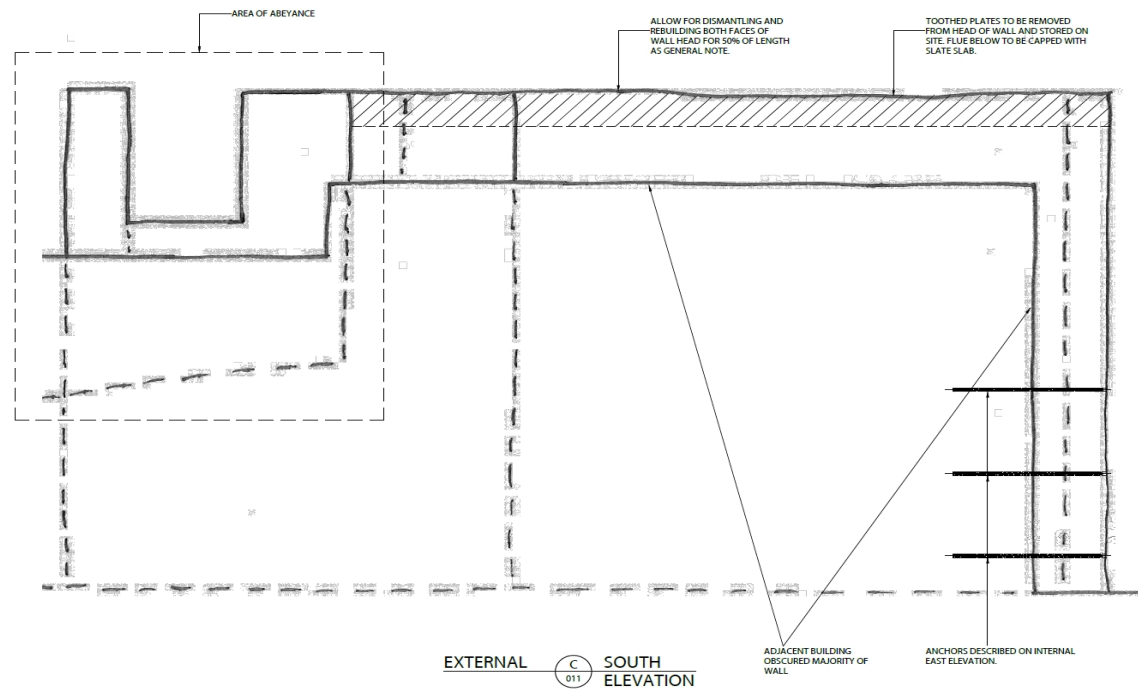
- EXTERNAL SOUTH ELEVATION GENERAL NOTES**
- ACCESS IS ANTICIPATED TO BE BY CHERRY PICKER AND TRADITIONAL SCAFFOLD TO INSIDE FACE
 - 30-40% VEGETATION COVER TO BE REMOVED (6-8.5m)
 - ALLOW FOR PIECEMEAL REPOINTING AS GENERAL NOTE TO 70-80% OF ELEVATION (15-17m)

External South Elevation									
EM_ES_1	Rebuild wall head	Both faces of stonework to be dismantled and rebuilt as general note	NA	7.5m	Cherry picker	5	m ²	1,400.00	7,000.00
EM_ES_2	Chimney cap	Toothed plates to be removed from wall head and stored on site	NA	7.5m	Cherry picker	2	No	100.00	200.00
EM_ES_3		Flue to be capped with slate slab	NA	7.5m		1	No	300.00	300.00

Location	Item	Description	Product Example	Height	Anticipated Access	No	Units	Unit Cost	Total Cost
EM_ES_4	Ivy cover	Remove ivy and make allowance for potential defects obscured by ivy at time of inspection	NA	Up to 7.5m	Cherry picker	8.5	m ²	15.00	127.50
		Associated repairs				1	P Sum	2,000.00	2,000.00
EM_ES_5	Repointing	Allowance for piecemeal repointing as general note	NA	Up to 7.5m	Cherry picker	17	m ²	75.00	1,275.00
EM_ES_6	Obscured	90% of elevation obscured by adjacent building. Assuming no access will be provided during works therefore no works anticipated	NA	NA	NA	NA	NA	NA	
		Access Provision				1	Item	2,500.00	2,500.00

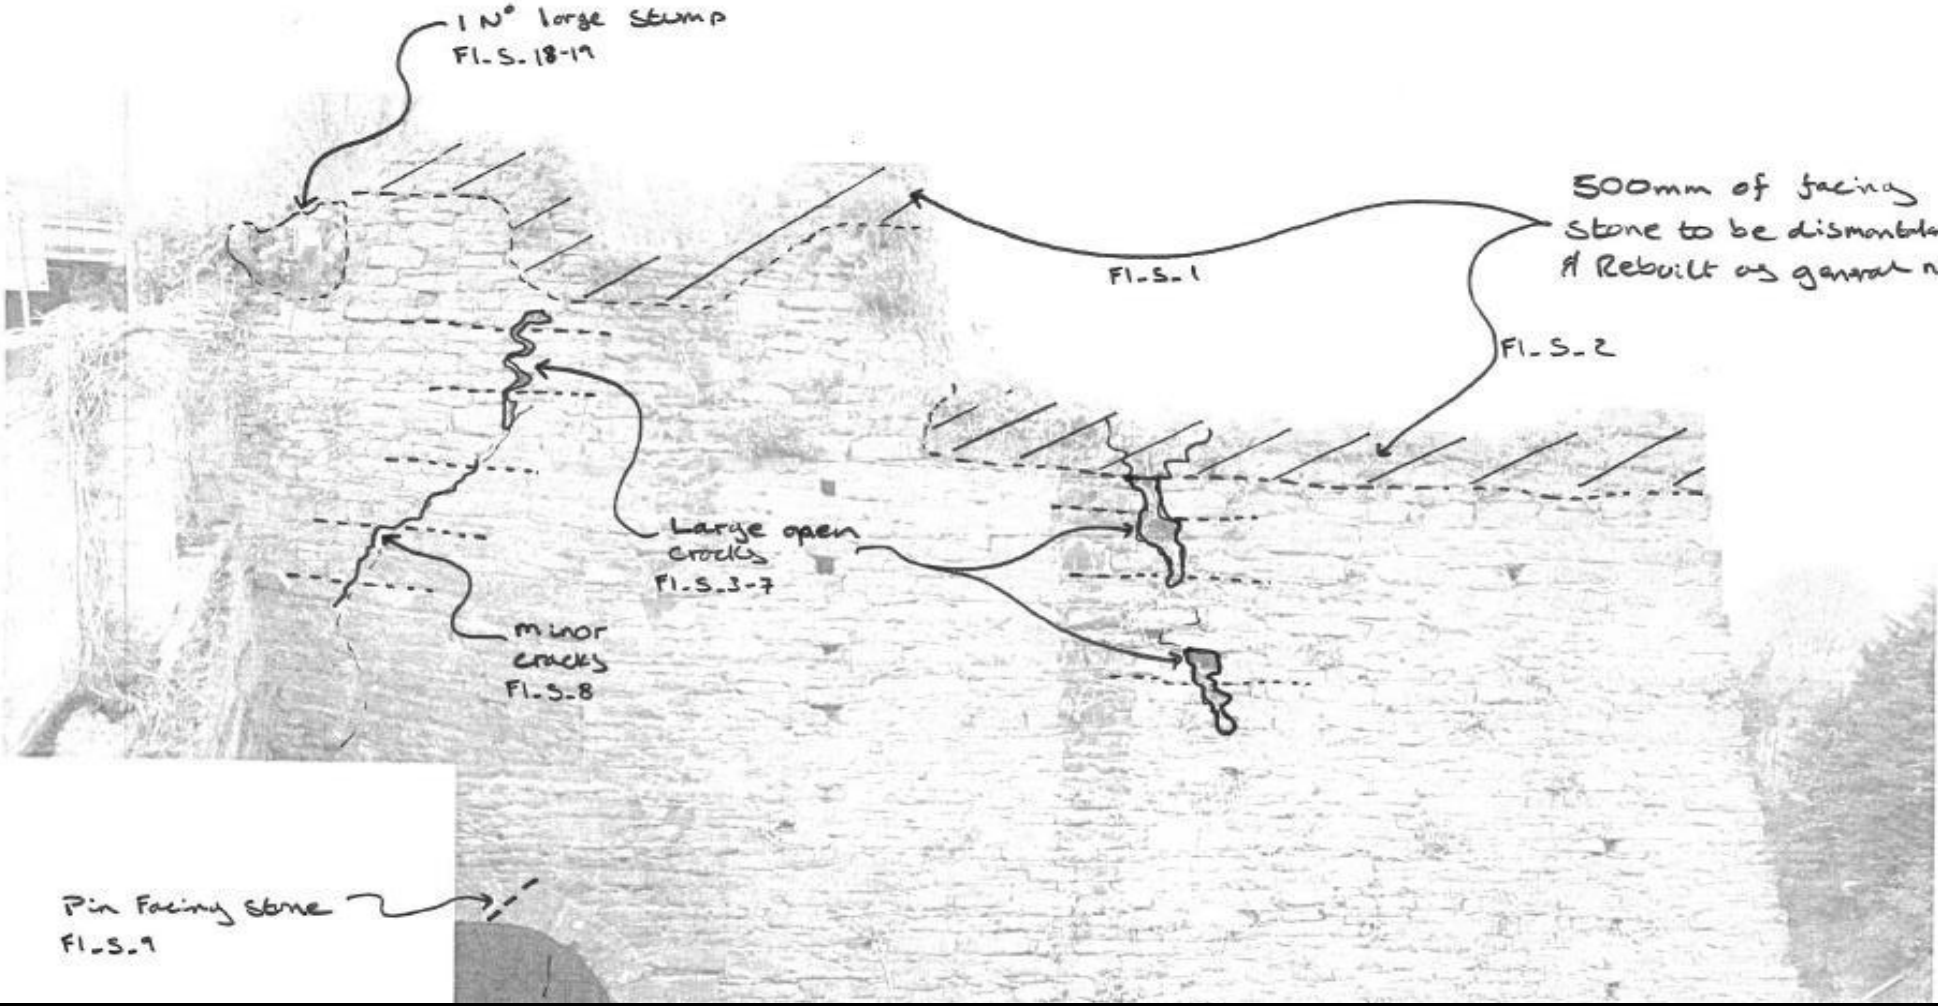
<p>The diagram shows a stone wall with several areas of concern marked by dashed lines and arrows. The annotations include:</p> <ul style="list-style-type: none">1 N° large stump (FI-S-18-19) at the top left corner.500mm of facing stone to be dismantled & Rebuilt as general note (FI-S-2) along the top edge.Large open cracks (FI-S-3-7) in the middle section.minor cracks (FI-S-8) in the lower left section.Pin Facing Stone (FI-S-9) at the bottom left corner. <p>The wall is labeled with FI-S-1 and FI-S-2 in the center and right sections.</p>

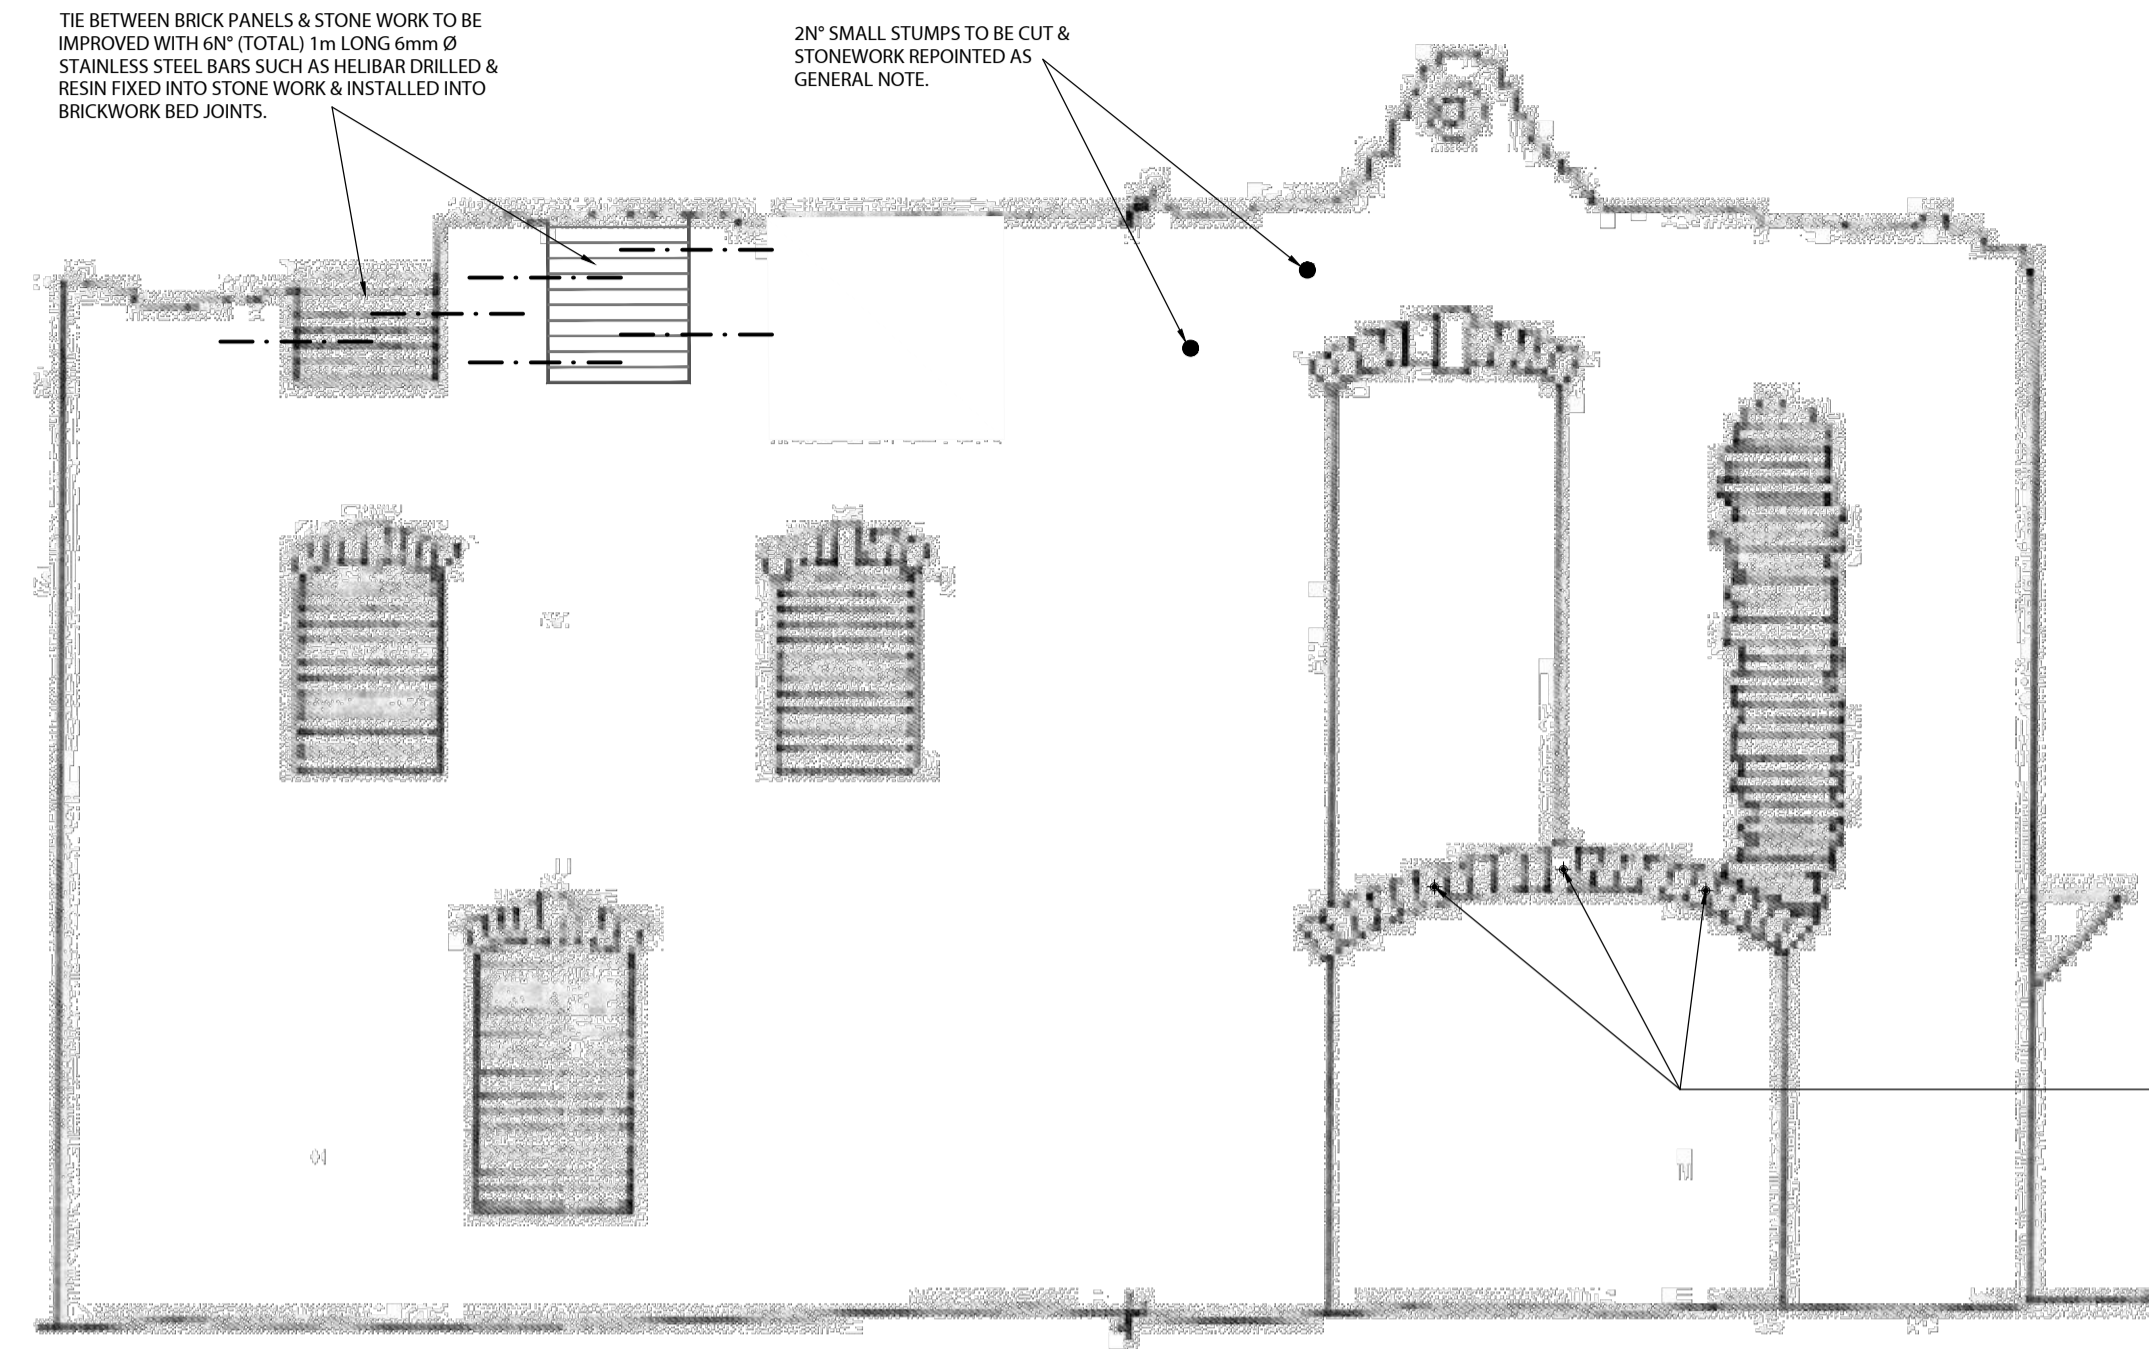
EXTERNAL (A) NORTH ELEVATION

ARCH SOFFIT CRACK TO BE REPAIRED WITH 3N° 12mm Ø 500mm LONG CINTEC ANCHORS OR SIMILAR APPROVED. CRACK TO BE DEEP REPOINTED.

- NORTH ELEVATION GENERAL ITEMS**
- ACCESS FOR ALL REPAIRS ANTICIPATED TO BE BY CHERRY PICKER OR ALUMINIUM SCAFFOLD TOWERS.
 - 5-10% IVY COVER TO BE REMOVED.
 - REBED LOOSE STONES AT WALL HEAD ALLOW APPROX 10N°.
 - ALLOW FOR PIECEMEAL REPOINTING AS GENERAL NOTE TO 10-20% OF ELEVATIONS.

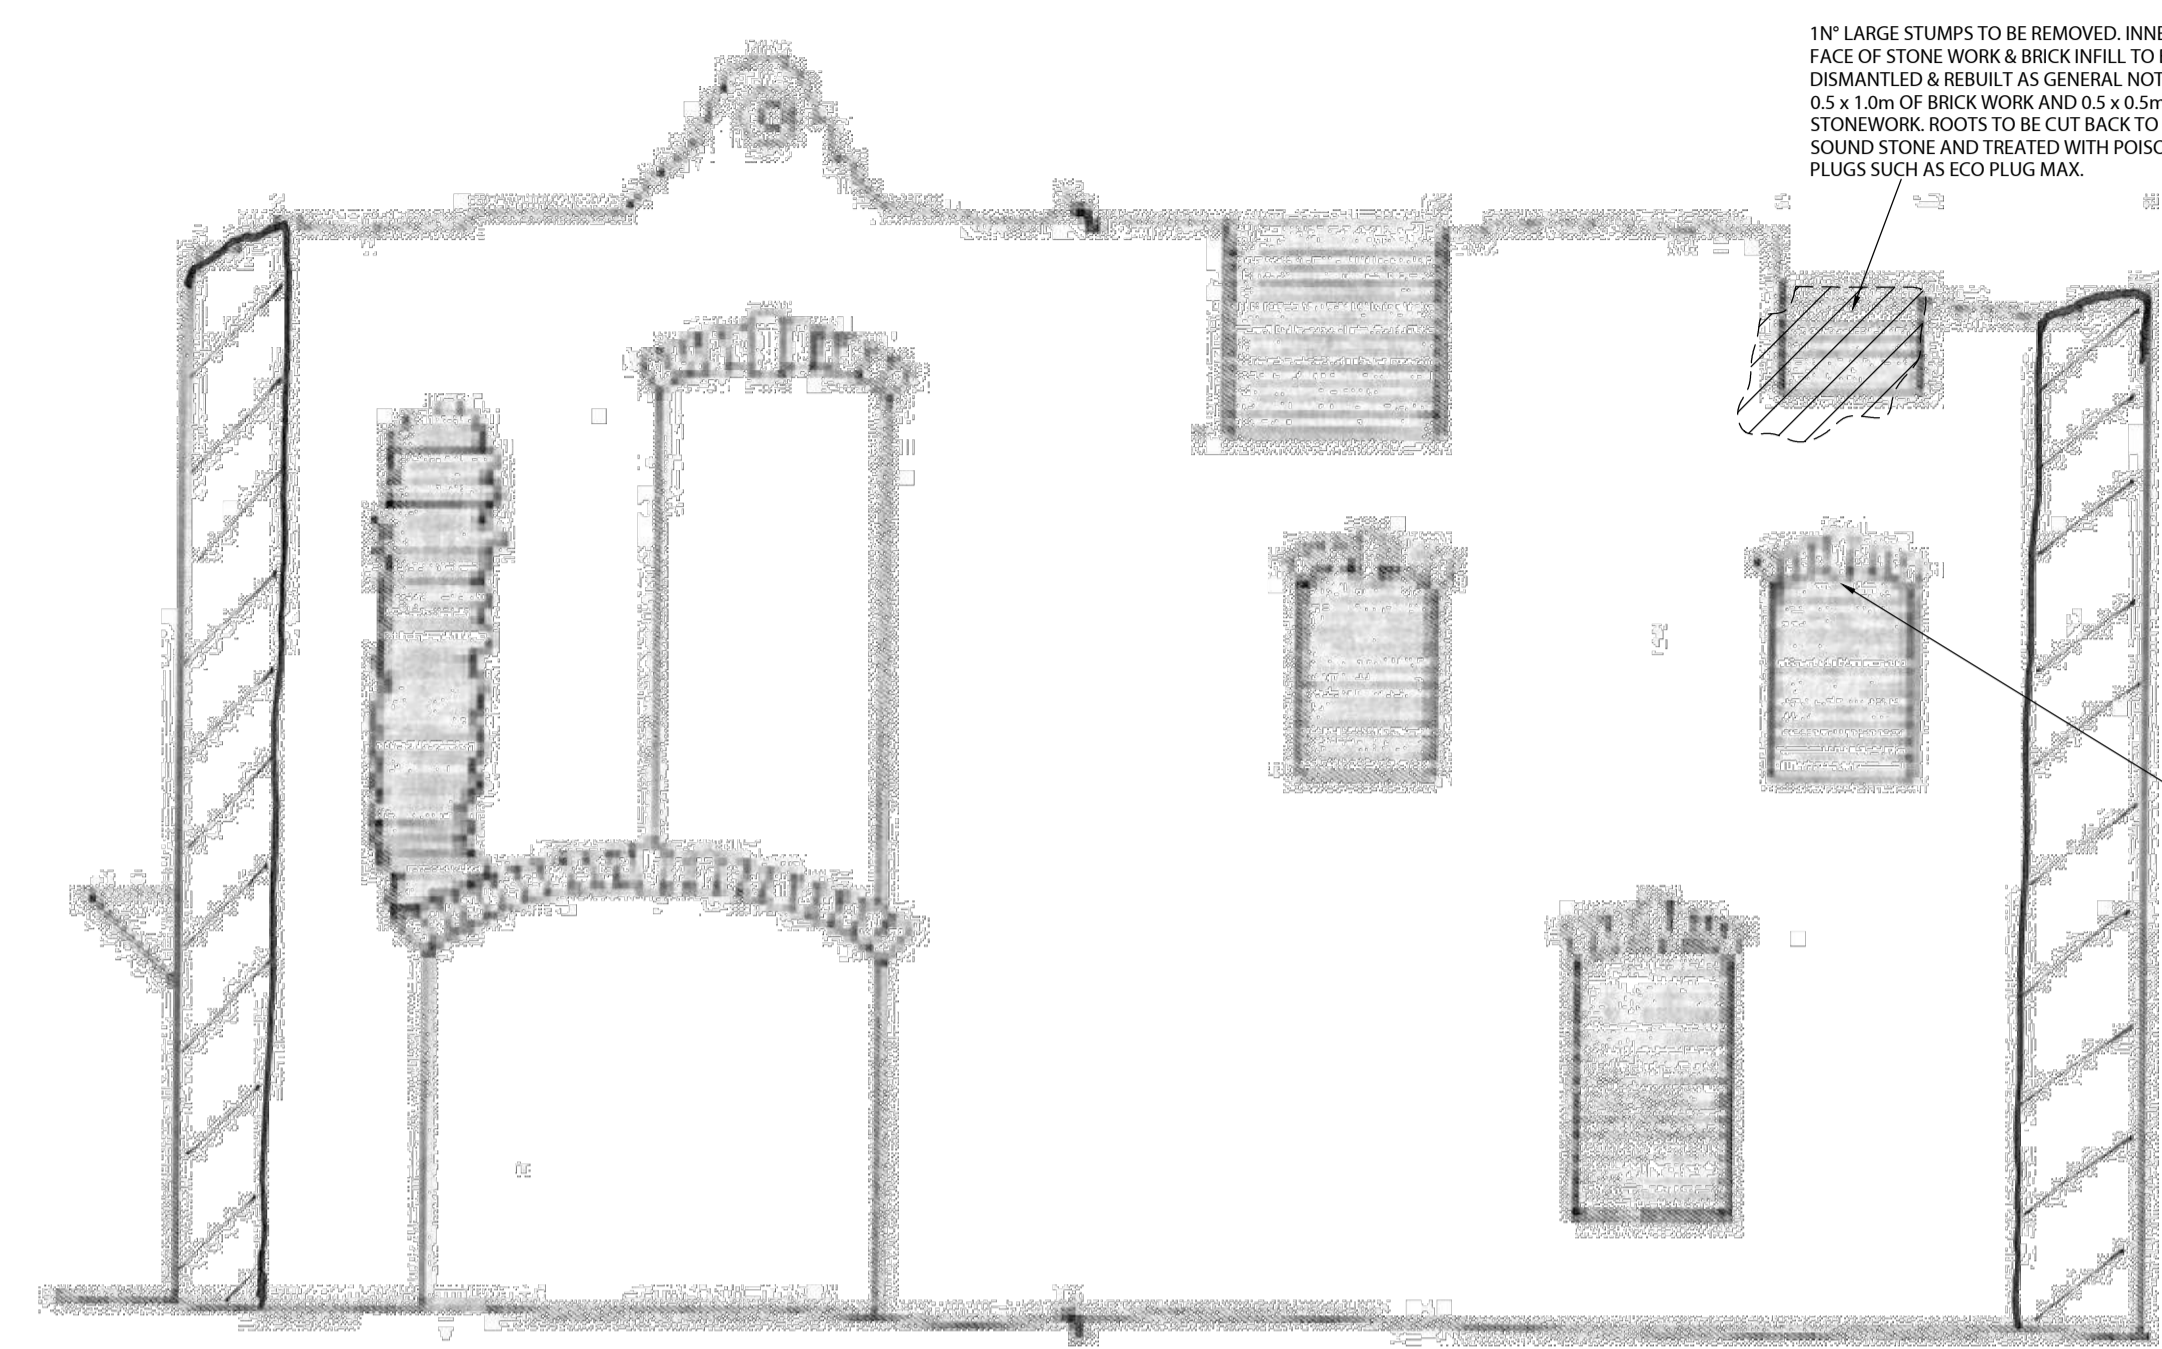
INTERNAL (B) NORTH ELEVATION

1N° LARGE STUMPS TO BE REMOVED. INNER FACE OF STONE WORK & BRICK INFILL TO BE DISMANTLED & REBUILT AS GENERAL NOTE. 0.5 x 1.0m OF BRICK WORK AND 0.5 x 0.5m STONEMASONRY. ROOTS TO BE CUT BACK TO SOUND STONE AND TREATED WITH POISON PLUGS SUCH AS ECO PLUG MAX.

DRY PACK BETWEEN TIMBER LINTEL AND STONEMASONRY OVER.

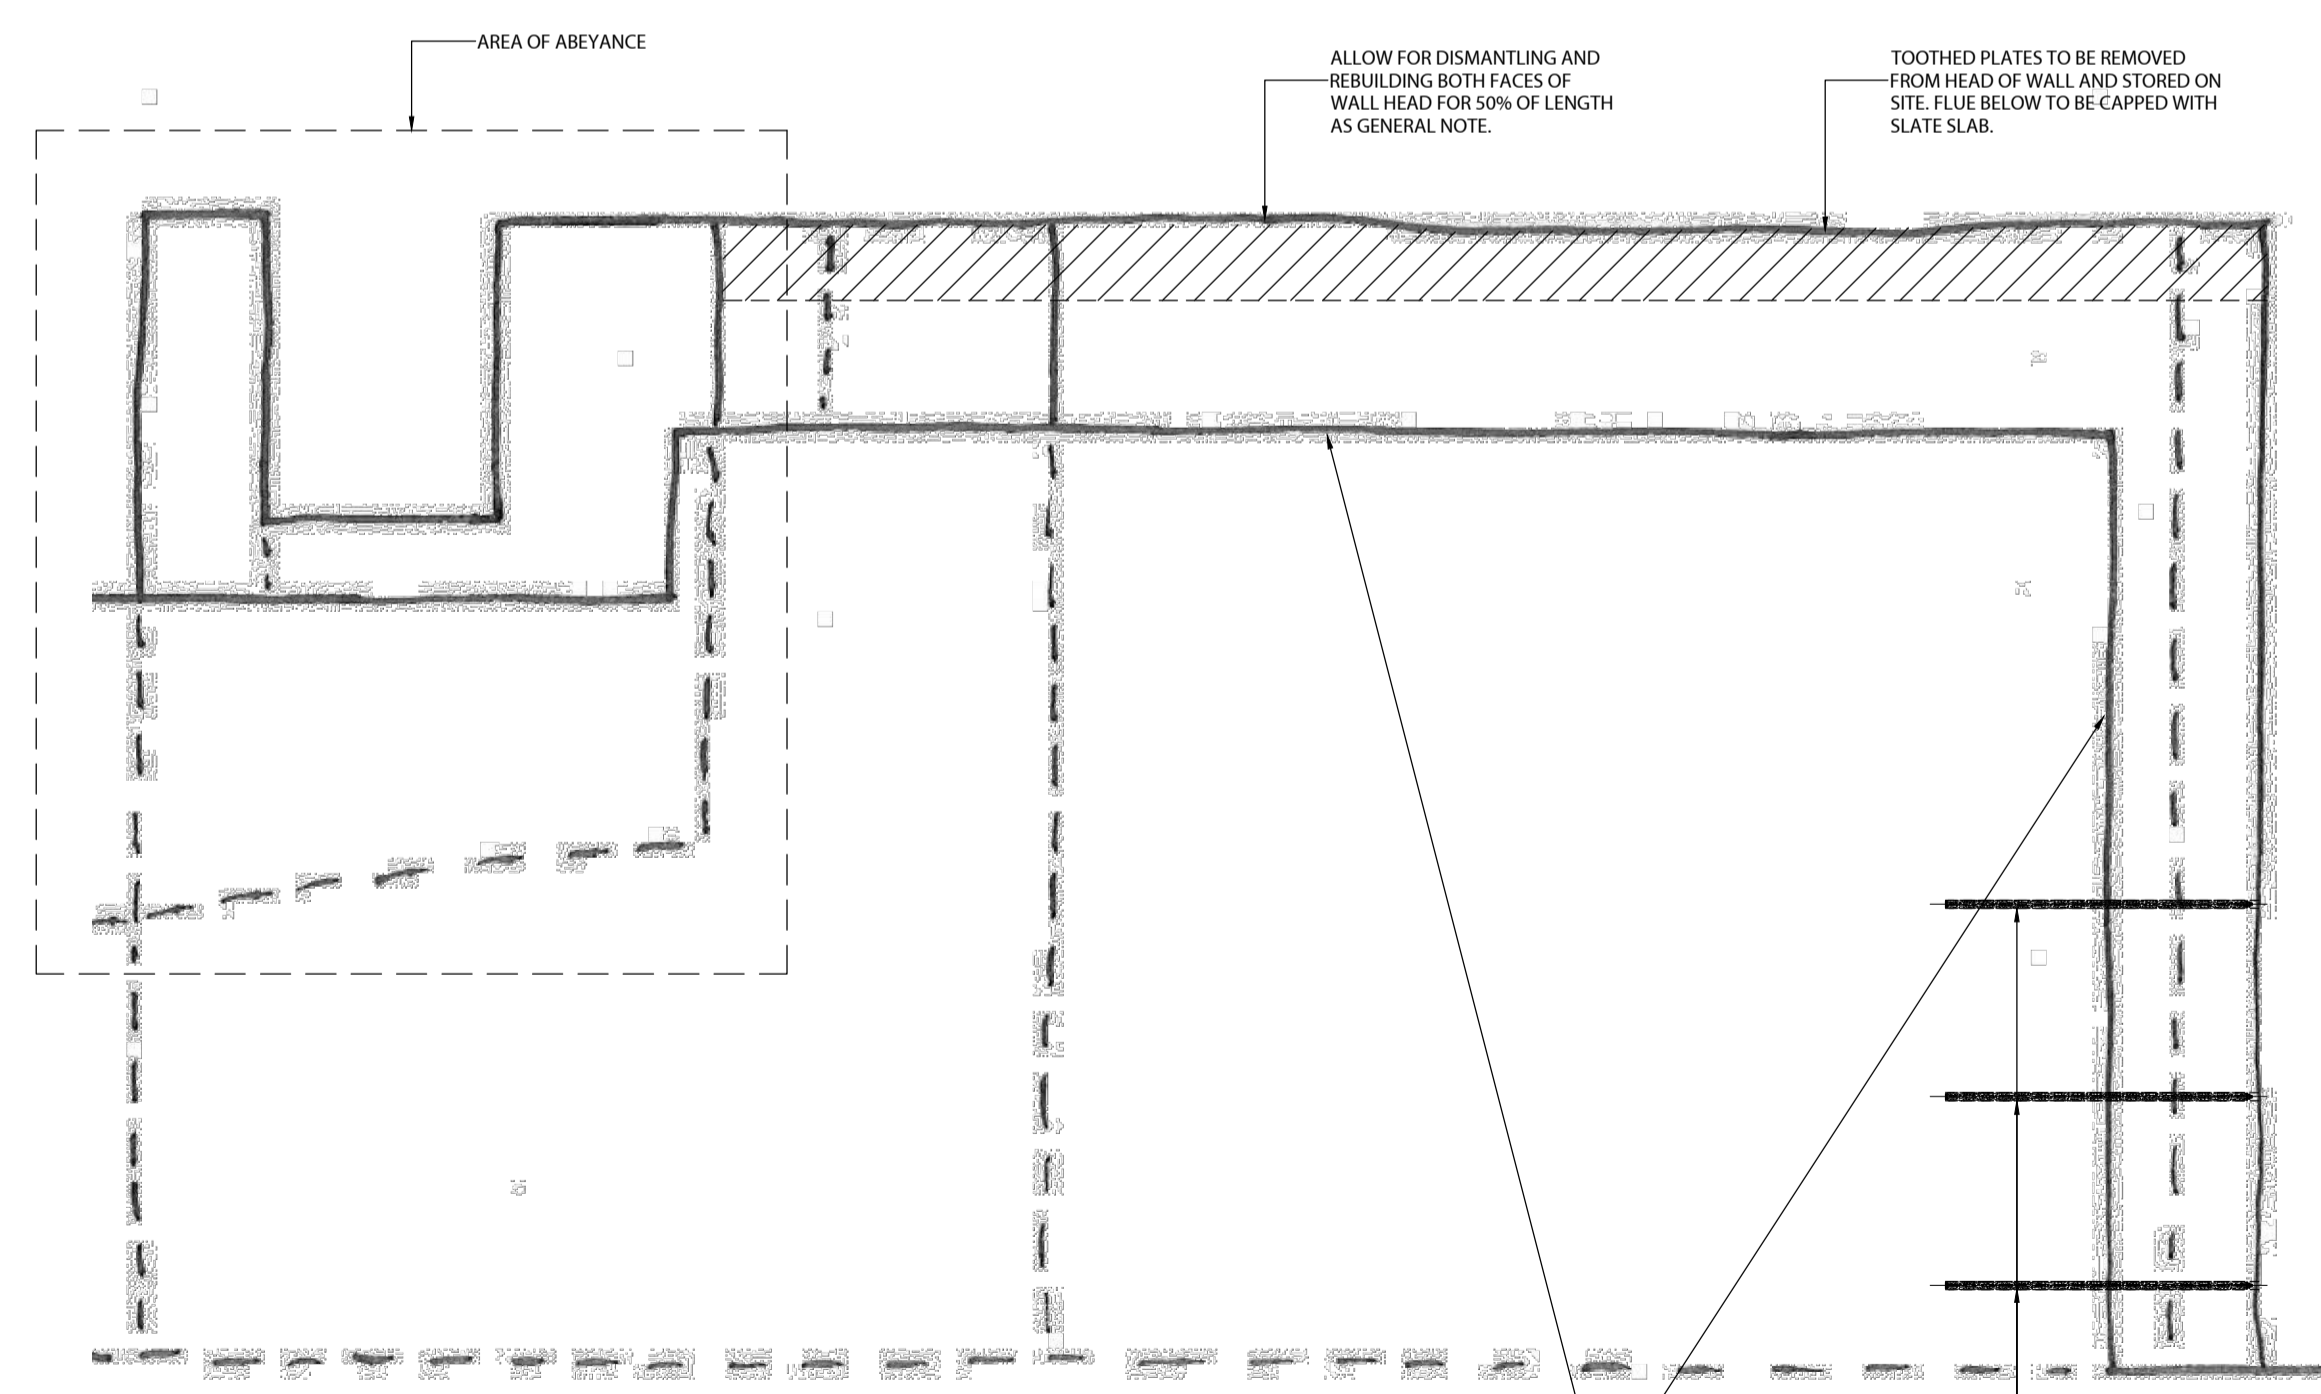
EXTERNAL (C) SOUTH ELEVATION

ADJACENT BUILDING OBSCURED MAJORITY OF WALL

ANCHORS DESCRIBED ON INTERNAL EAST ELEVATION.

- EXTERNAL SOUTH ELEVATION GENERAL NOTES**
- ACCESS IS ANTICIPATED TO BE BY CHERRY PICKER AND TRADITIONAL SCAFFOLD TO INSIDE FACE.
 - 30-40% VEGETATION COVER TO BE REMOVED (6.4.2017).
 - ALLOW FOR PIECEMEAL REPOINTING AS GENERAL NOTE TO 70-80% OF ELEVATION (15-17m).
