Neath Abbey Ironworks

Summary of Structural Investigation

The Friends of Neath Abbey Iron Company

Project Number: 9446

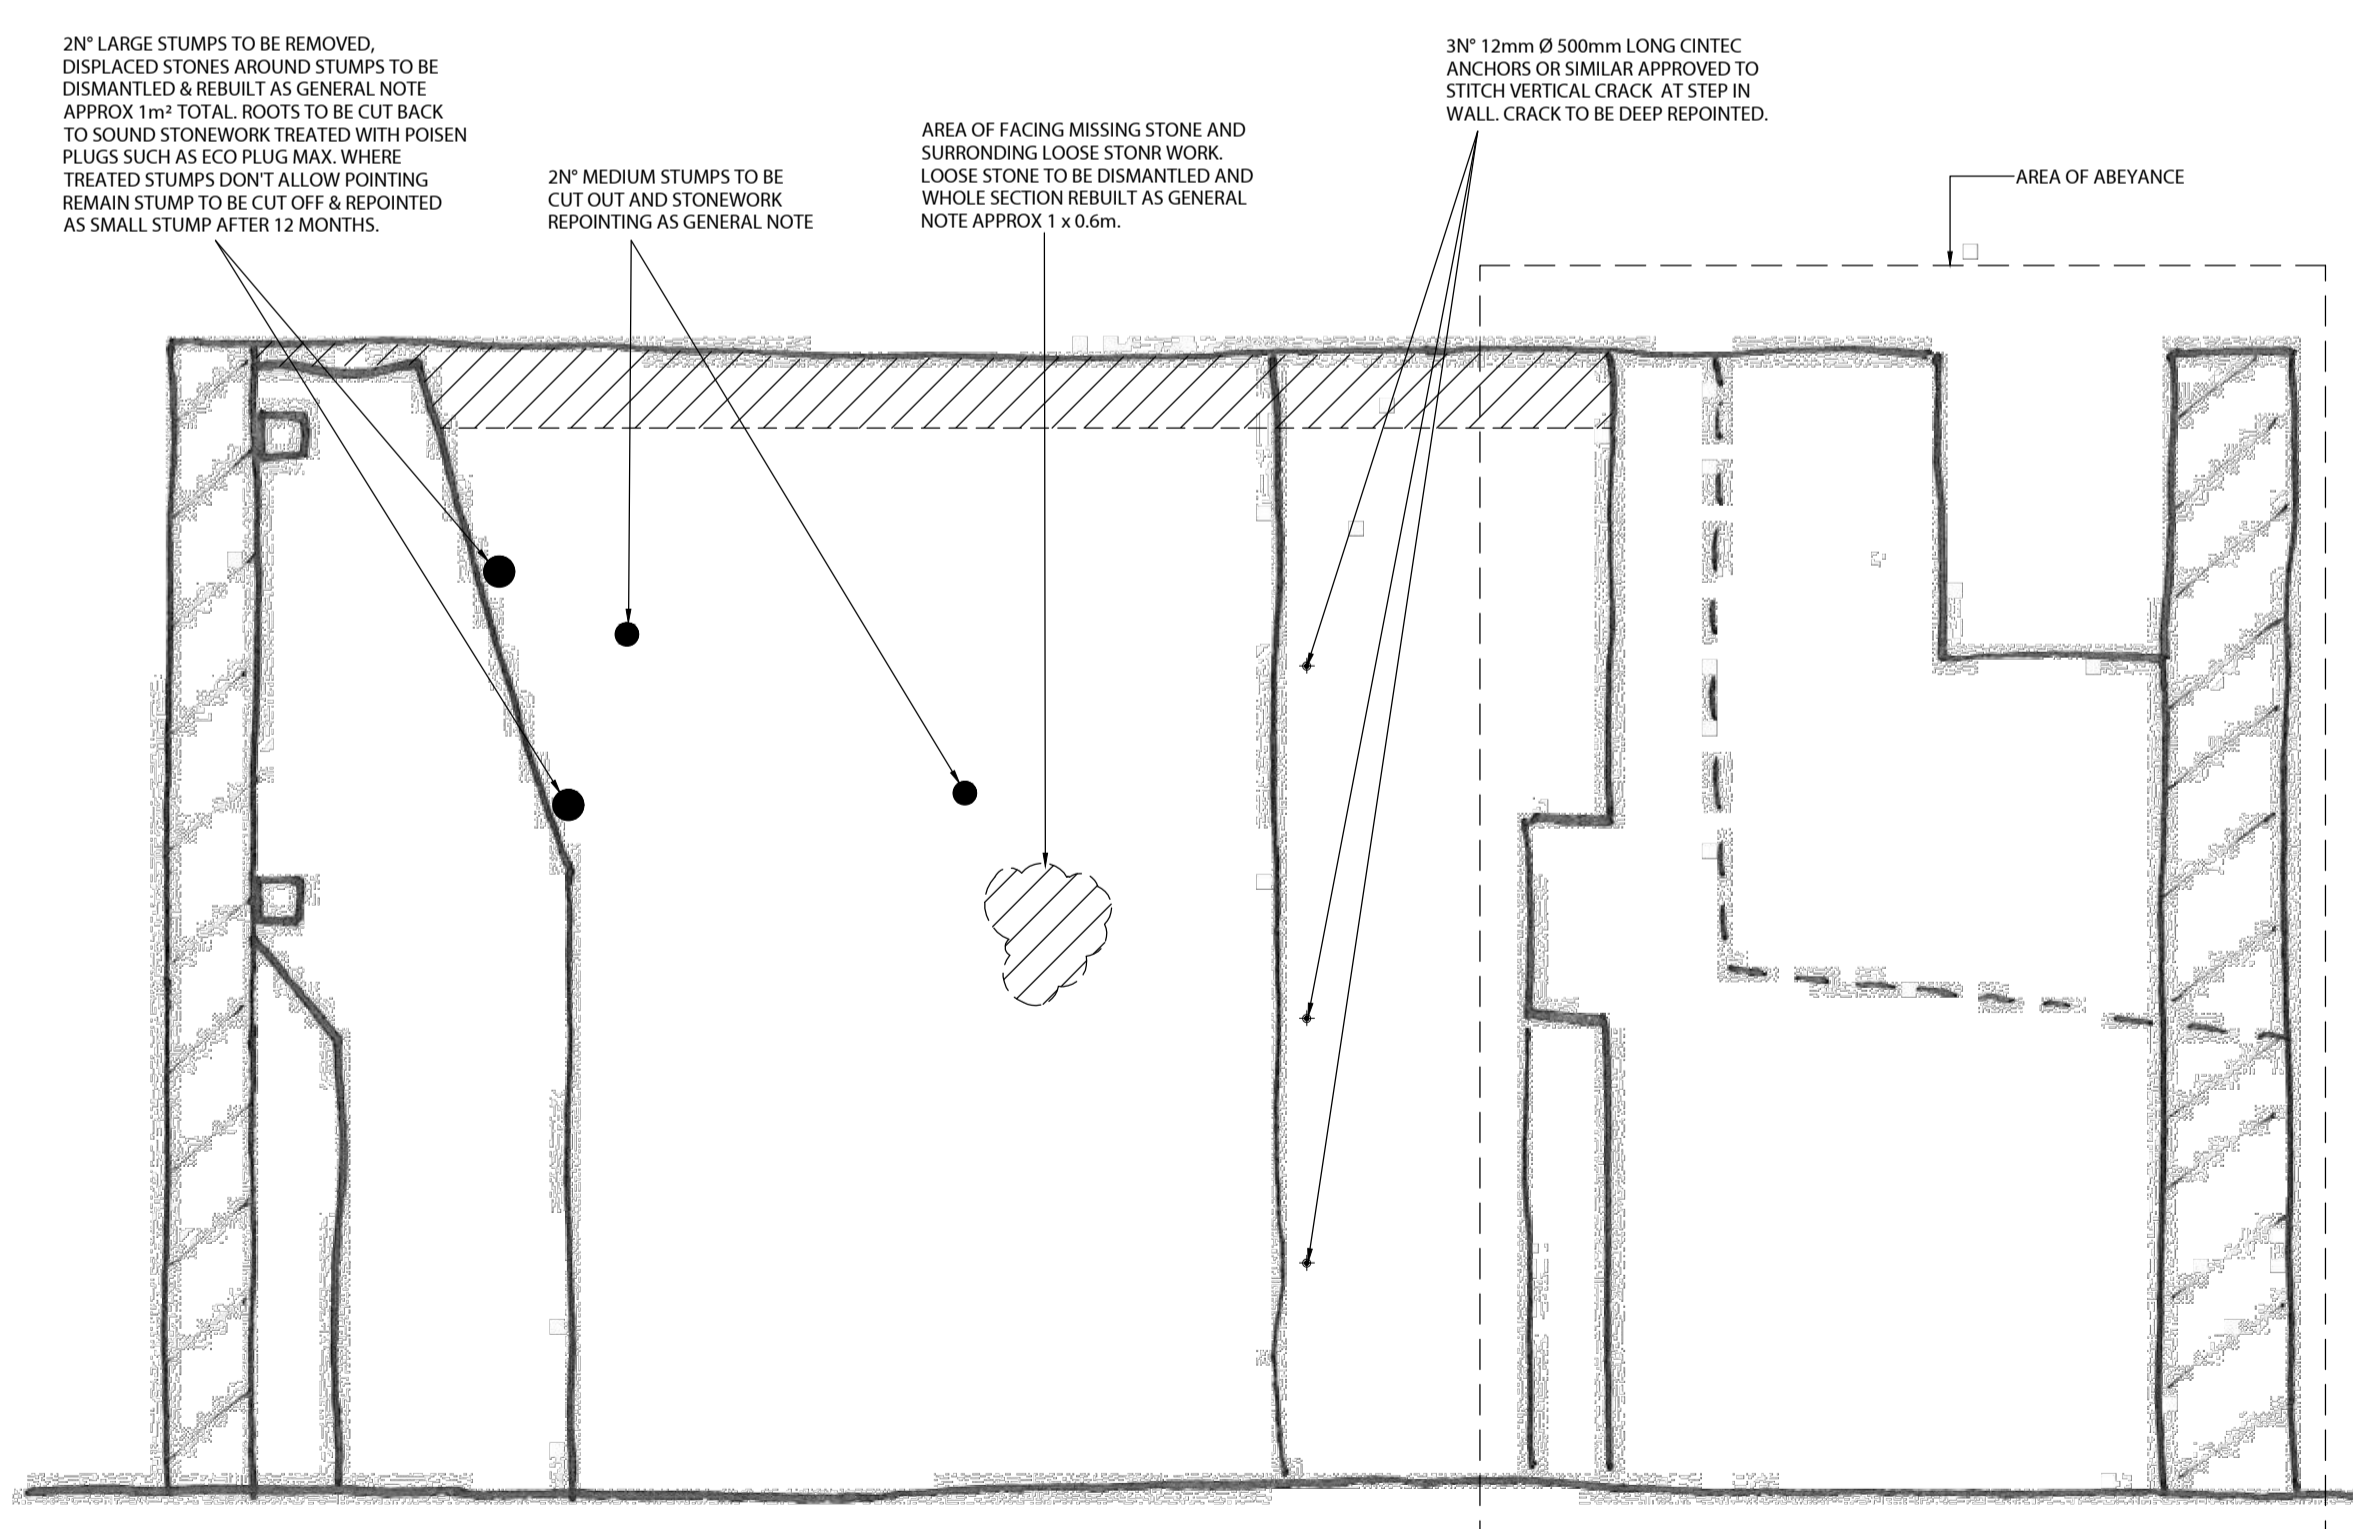
INTERNAL (D) SOUTH ELEVATION

2N° LARGE STUMPS TO BE REMOVED. DISPLACED STONES AROUND STUMPS TO BE DISMANTLED & REBUILT AS GENERAL NOTE APPROX 1m² TOTAL. ROOTS TO BE CUT BACK TO SOUND STONEMASONRY TREATED WITH POISON PLUGS SUCH AS ECO PLUG MAX. WHERE TREATED STUMPS DON'T ALLOW POINTING REMAIN STUMP TO BE CUT OFF & REPOINTED AS SMALL STUMP AFTER 12 MONTHS.

AREA OF FACING MISSING STONE AND SURROUNDING LOOSE STONEMASONRY. LOOSE STONE TO BE DISMANTLED AND WHOLE SECTION REBUILT AS GENERAL NOTE APPROX 1 x 0.6m.

3N° 12mm Ø 500mm LONG CINTEC ANCHORS OR SIMILAR APPROVED TO STITCH VERTICAL CRACK AT STEP IN WALL. CRACK TO BE DEEP REPOINTED.

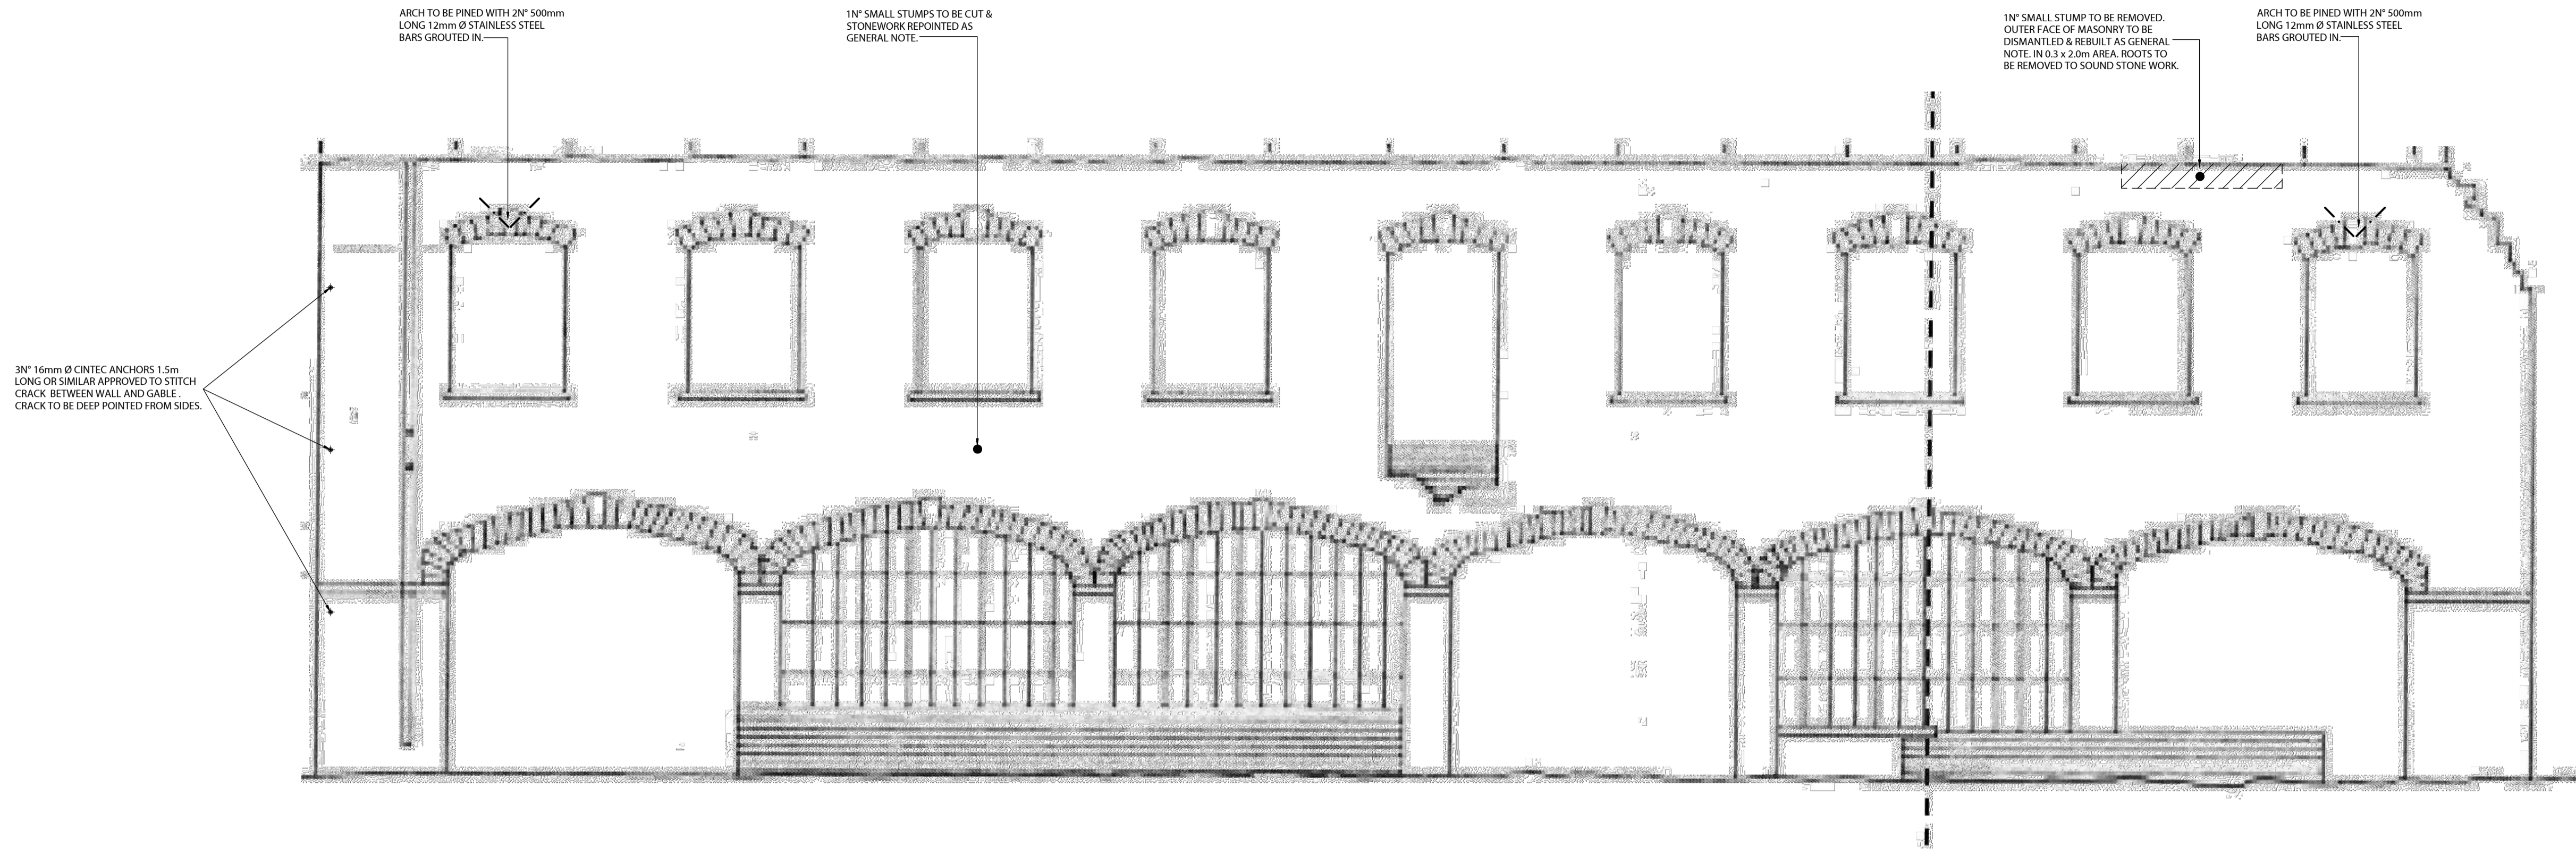
- GENERAL ELEVATION ITEMS**
- ACCESS FOR ALL REPAIRS ANTICIPATED TO BE BY CHERRY PICKERS OR ALUMINIUM SCAFFOLD TOWERS
 - 0.5% IVY COVER TO BE REMOVED.
 - REBED LOOSE STONES AT WALL HEAD. ALLOW FOR APPROX 20 BY.
 - ALLOW FOR PIECEMEAL REPOINTING AS GENERAL NOTES TO 0-10% OF ELEVATION.

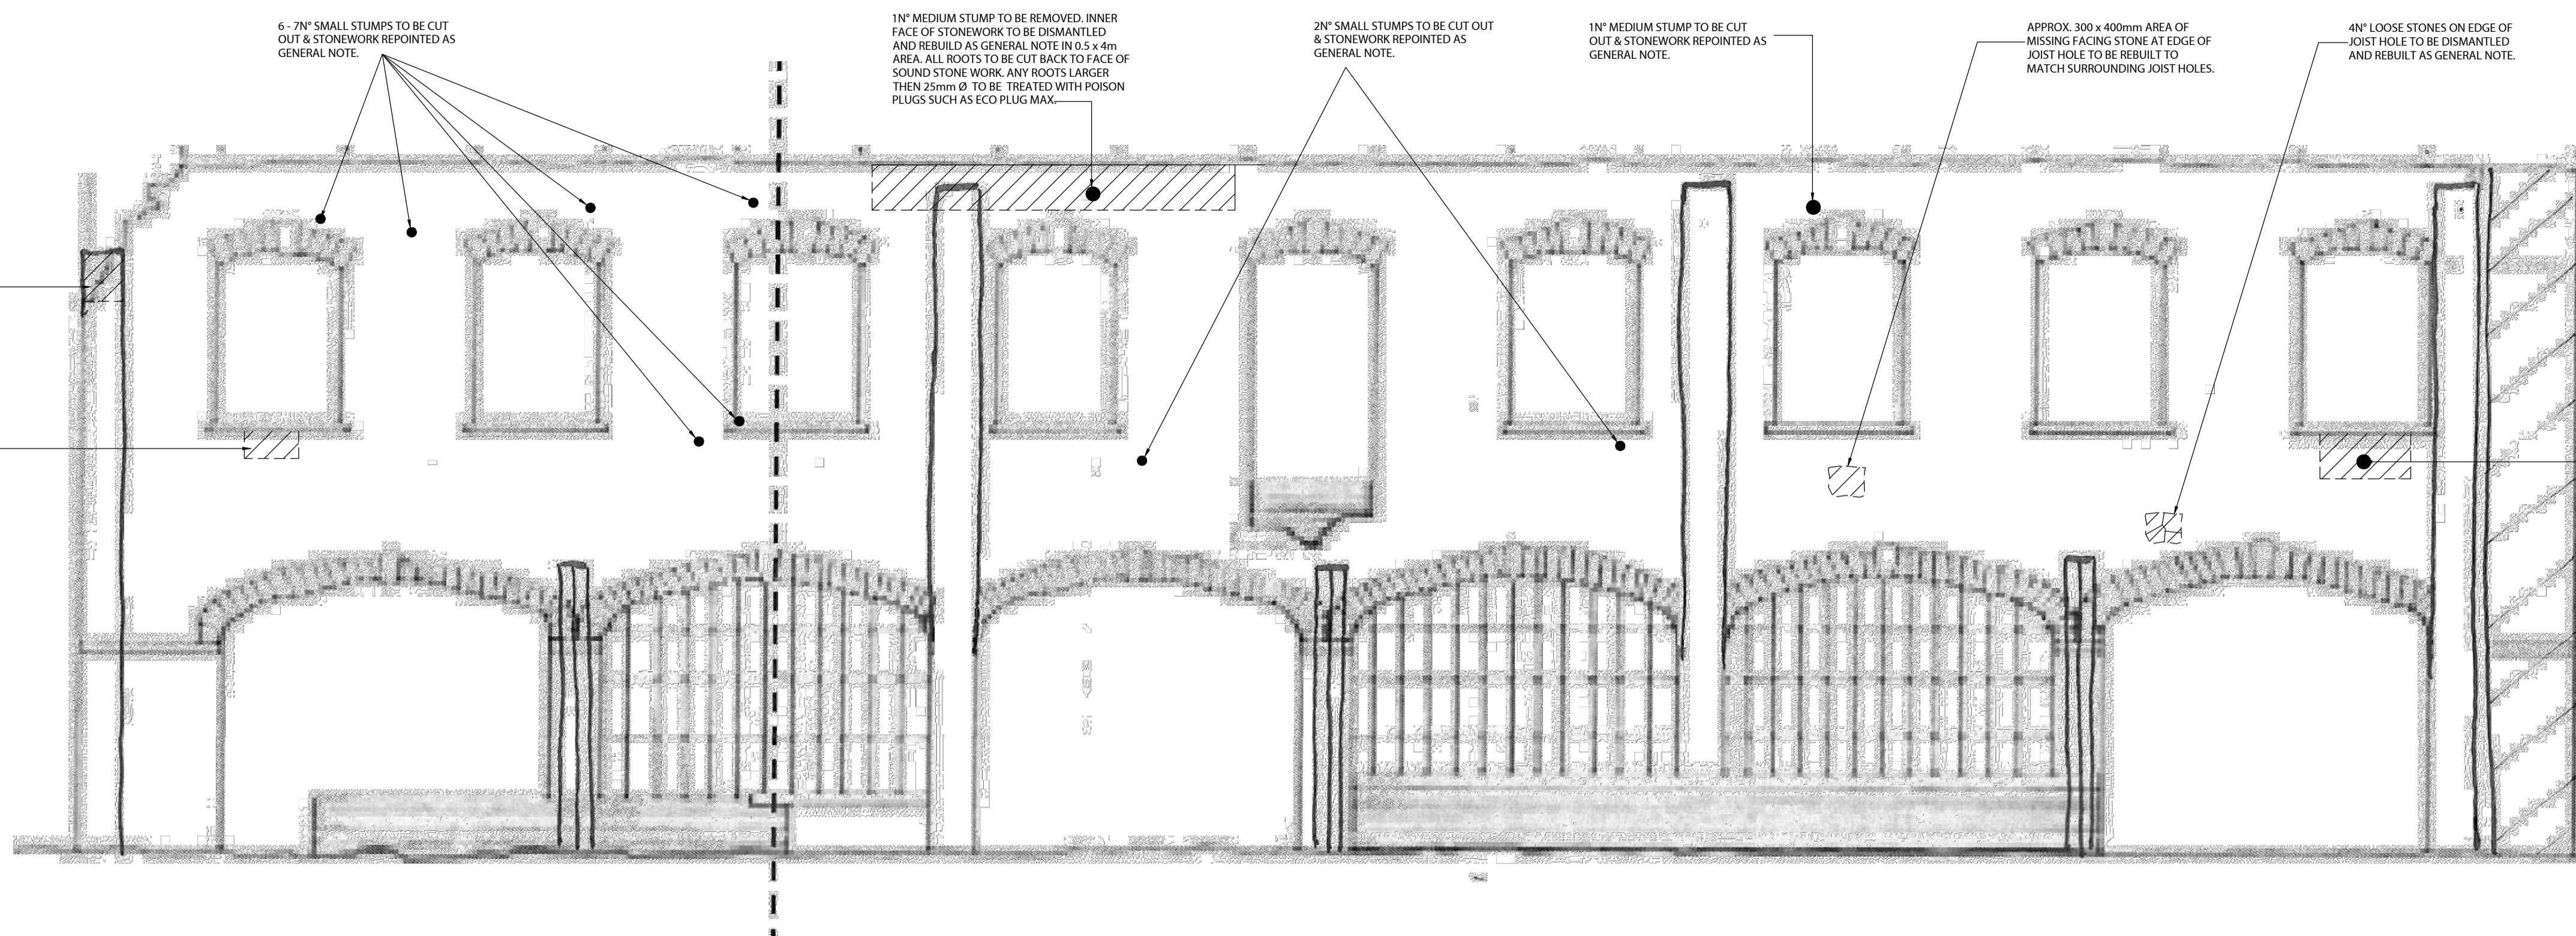
- ACCESS FOR ALL REPAIRS ANTICIPATED TO BE BY CHERRY PICKERS OR ALUMINIUM SCAFFOLD TOWERS
- 10-20% IVY COVER TO BE REMOVED
- ALLOW FOR PIECEMEAL REPOINTING AS GENERAL NOTES TO 20-30% OF ELEVATION.

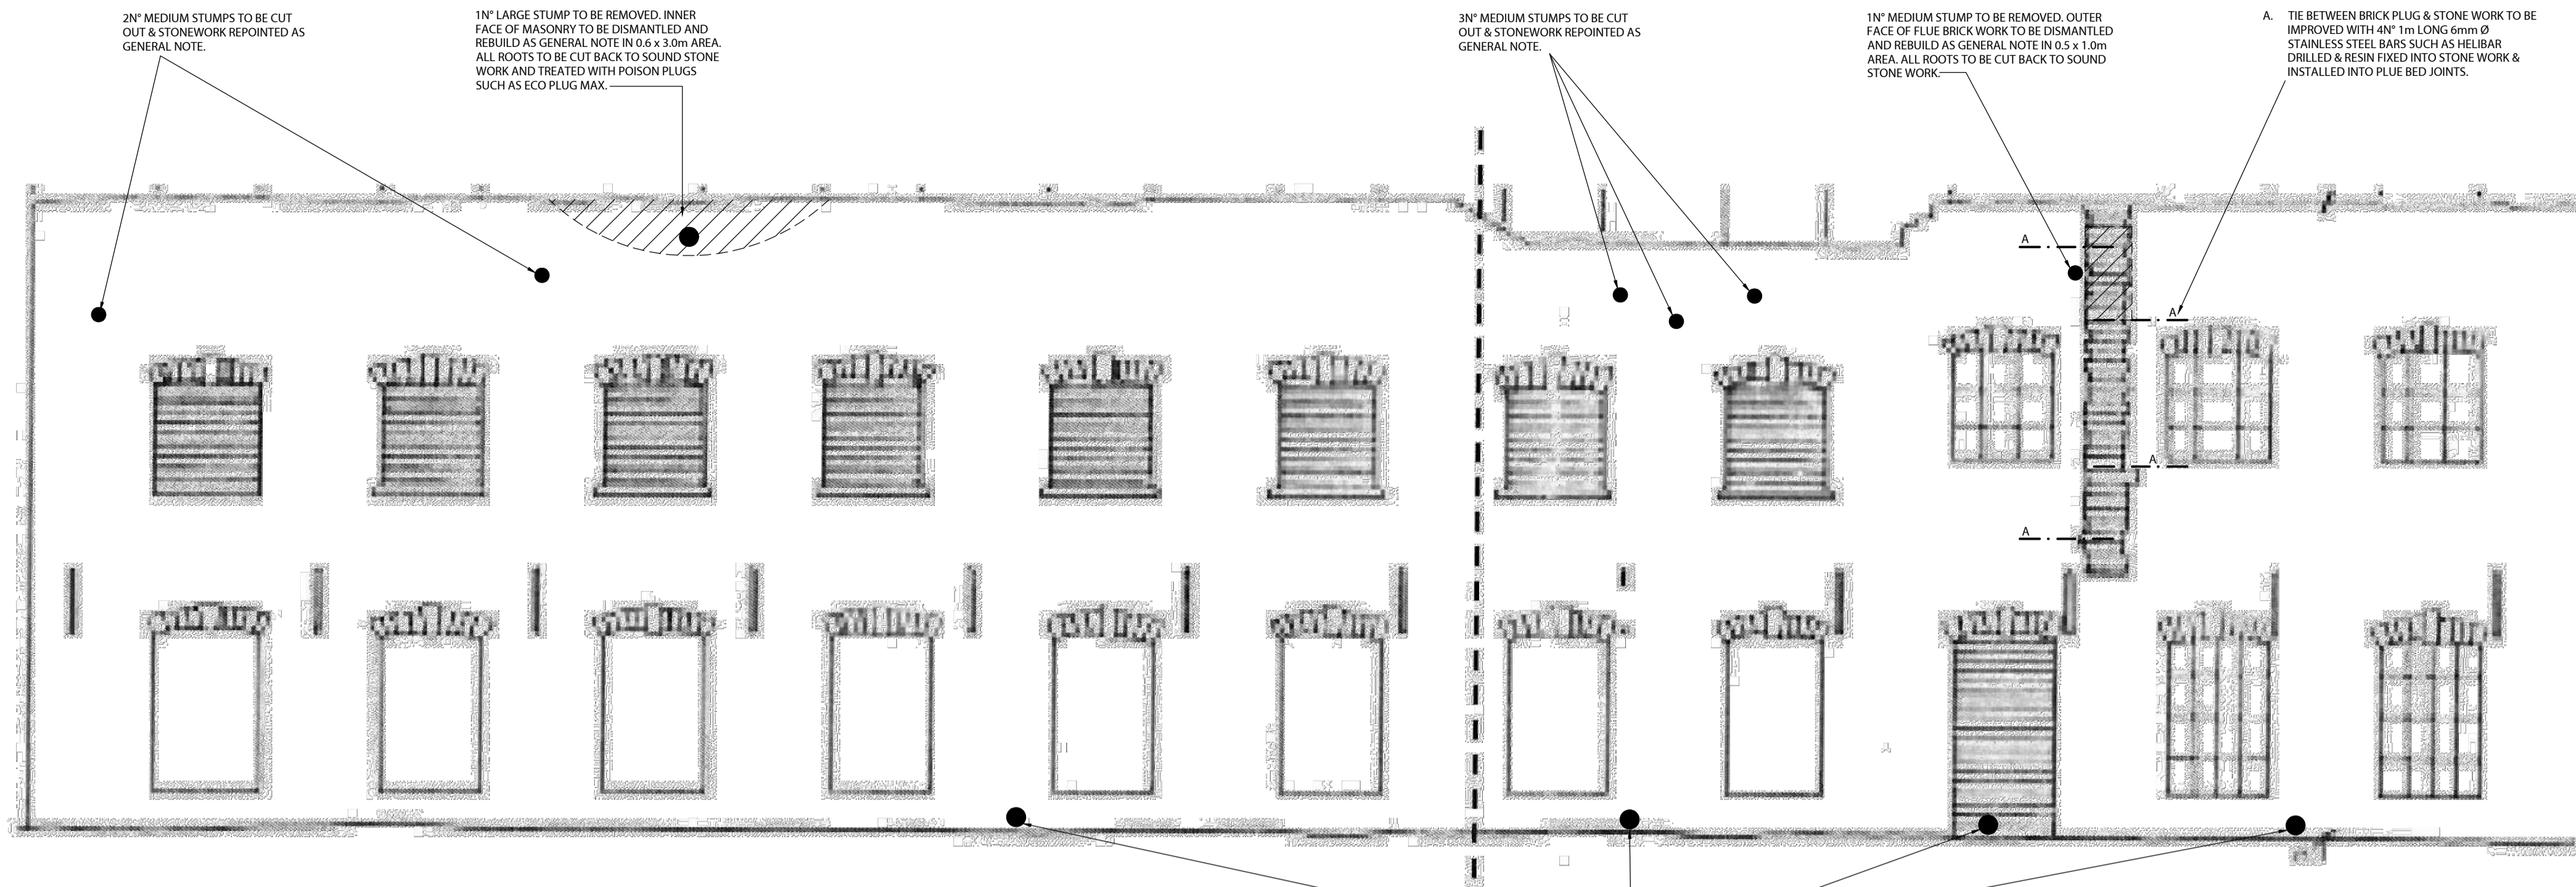
EXTERNAL WEST ELEVATION

- GENERAL ELEVATION NOTES**
- ACCESS FOR ALL REPAIRS ANTICIPATED TO BE BY CHERRY PICKERS OR ALUMINIUM SCAFFOLD TOWERS.
 - 10-20% IVY COVER TO BE REMOVED.
 - ALLOW FOR PIECEMEAL REPOINTING AS GENERAL NOTES TO 10-20% OF ELEVATION.
 - REBED LOOSE STONES @ WALL HEAD ALLOW FOR 30%.

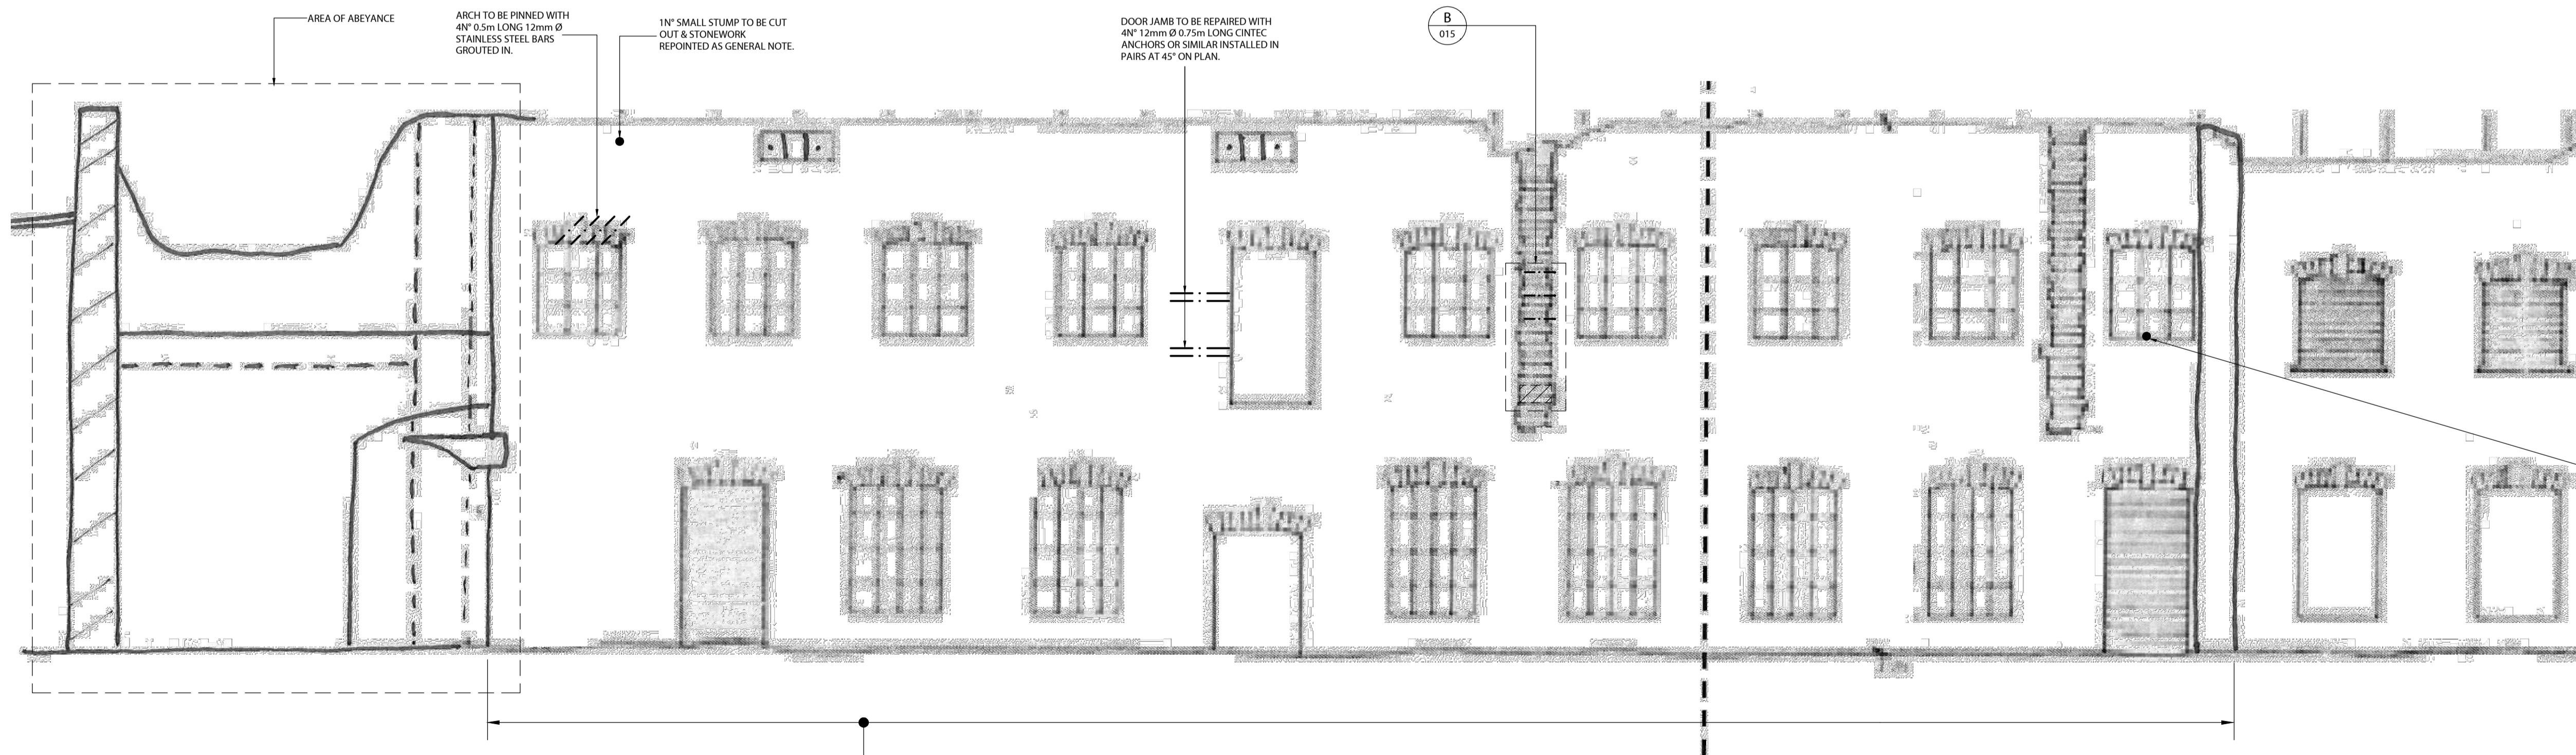
INTERNAL WEST ELEVATION

- ALLOW FOR PIECEMEAL REPOINTING AS GENERAL NOTES TO 40-50% OF ELEVATION IN THIS AREA
- 10-20% IVY COVER TO BE REMOVED IN THIS AREA
- ACCESS FOR REPAIRS IN THIS AREA ANTICIPATED TO BE BY CHERRY PICKERS OR ALUMINIUM SCAFFOLD TOWERS BUT EXTENT OF REPOINTING MAY MAKE TRADITIONAL SCAFFOLD MORE ECONOMIC.
